May 2010

Walla Walla River, Mill Creek, and Coppei Creek Geomorphic Assessment

Walla Walla County Conservation District and
U.S. Forest Service, TEAMS Enterprise Unit

Compiled: April, 2010; Revised: May 2010

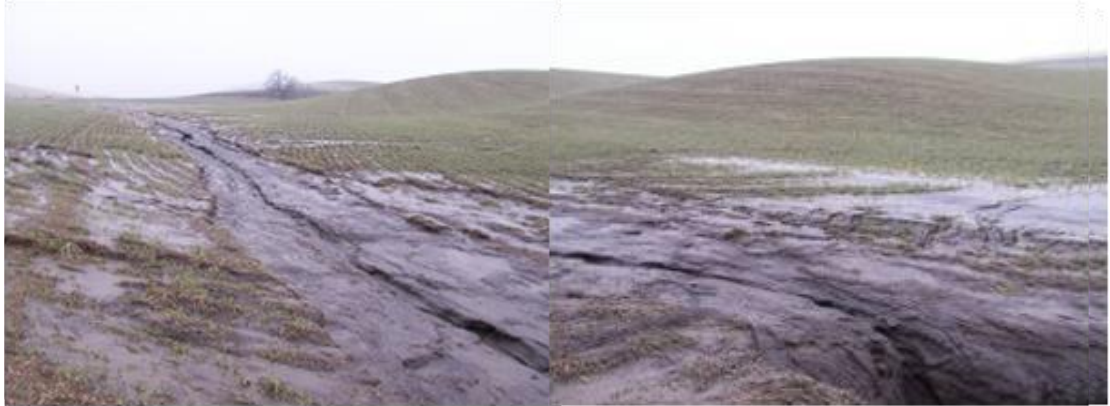
Observations of agricultural runoff along the assessment reaches indicate that during runoff events fine sediment is transported by side channels and road ditches to the assessment stream channels. For example, sheet and gully soil erosion was observed along Coppei Creek in January 2007 from nearby tilled wheat fields (figure 5). This was not a particularly big rainfall event, but it transported significant amounts of fine sediment into the stream channel. The small upland tributary channels along all of the assessment reaches often are plowed over, left void of vegetation filter strips along the channel bottoms to filter sediment from runoff. Fine sediment delivered to channels is a pollutant and has a detrimental effect on fish production and other aquatic life.

Figure 6. Soil sheet and gully erosion in loess soils in uplands above Coppei assessment reach (Alex Amonette photo, 2007)

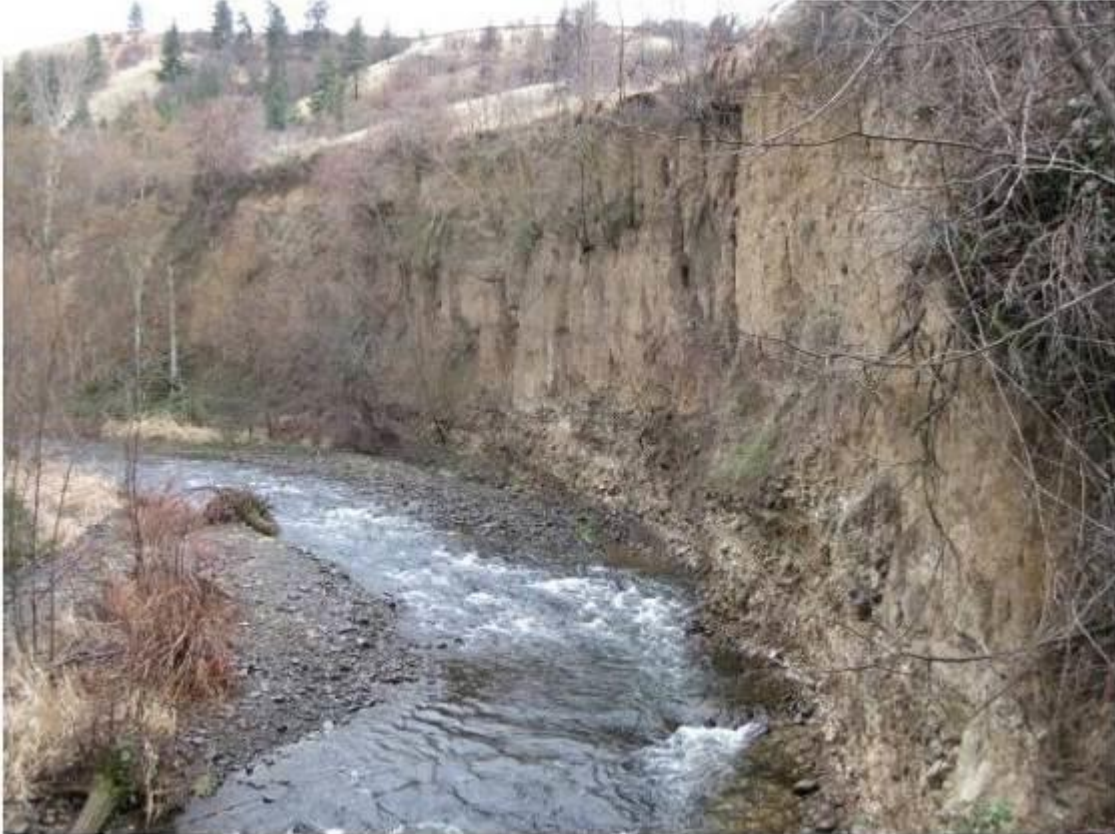
Figure 18. Eroding stream bank just above private bridge at RM 2.7

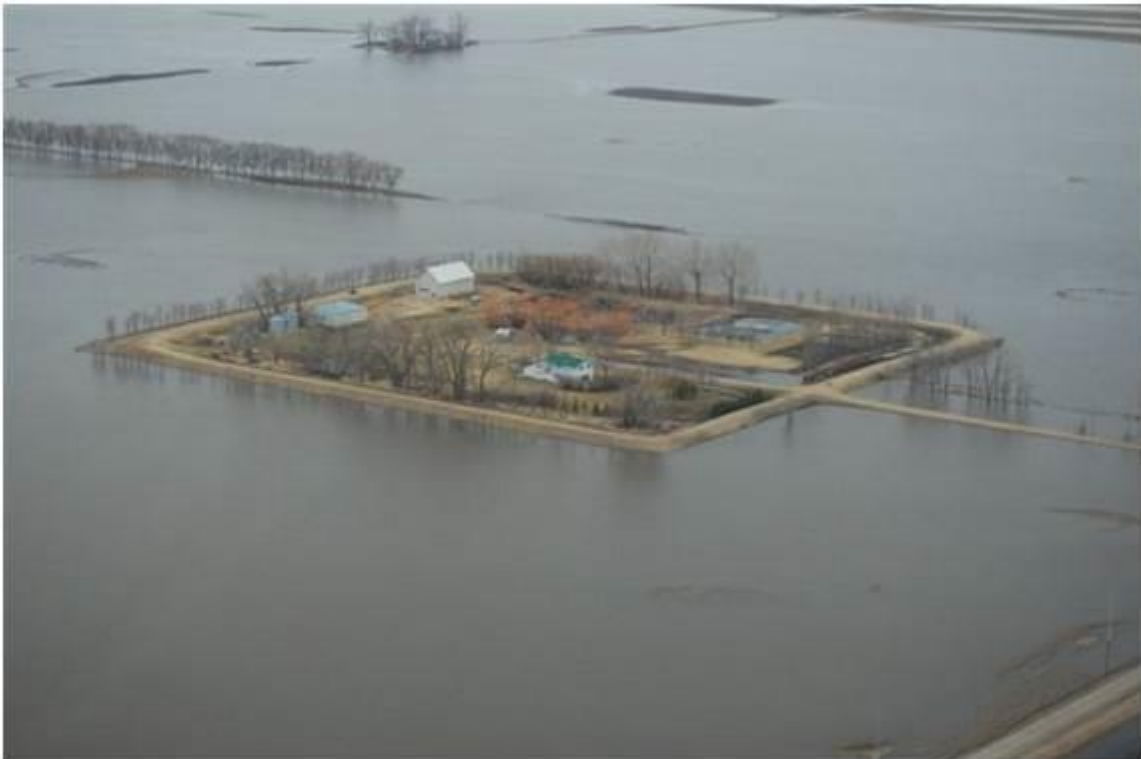
channels are important to identify and maintain to reduce the destructive force of floods. An overall strategy like the floodflow “cell” approach proposed by the U.S. Army Corps of Engineers (1997) retains or temporarily stores flood water in selected locations on the valley floor. “Cell” flooding is an inverse of traditional flood protection methods. Instead of restricting flow within a channel, flow is allowed to spread out over a broad floodplain. Critical infrastructure, homes, and emergency transportation corridors are located out of areas prone to flooding, or protected locally with ring dikes or other appropriate measures. This allows for maximum energy dissipation and flood storage, minimizes dike breaches and overtopping, and allows for much more rapid drainage of farm fields after the flood peak has receded. A similar plan should be developed for the assessment reaches before any river management or further development takes place.

Figure 21. Ring dike protecting property in floodplain in areas where levees failed

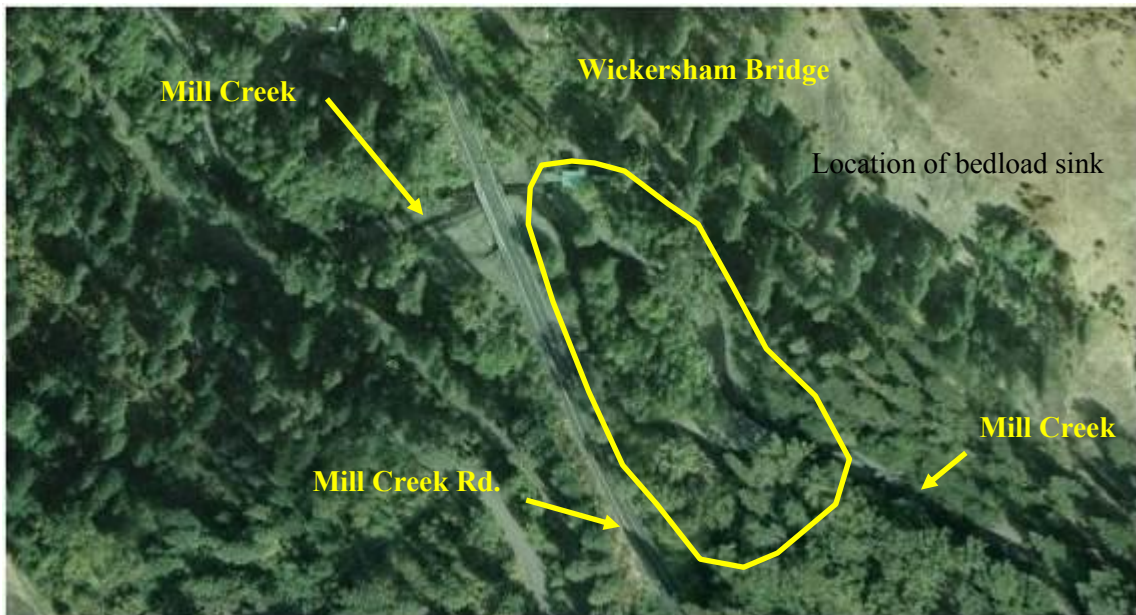
Elimination of the bedload trap caused by the Wickersham Bridge would initiate the process of improving stream stability and function throughout the Mill Creek reach. The channel below the Wickersham Bridge has been sediment starved because of the trap and has become steeper and less stable over time because of it. Reducing the steepness of the channel and providing for improved floodplain access through the use of levee setbacks in multiple locations would increase sinuosity, increase entrenchment and bankfull width-to-depth ratios, stabilize the channel, and improve riparian conditions. These actions would directly benefit aquatic habitat by reducing sediment inputs, improving large woody debris recruitment, and increasing shade over time.

Figure 24. Photo of artificial bedload trap caused by the placement of the Wickersham Bridge, Mill Creek, Walla Walla County, Washington (flow is from the bottom right corner to the top left corner)

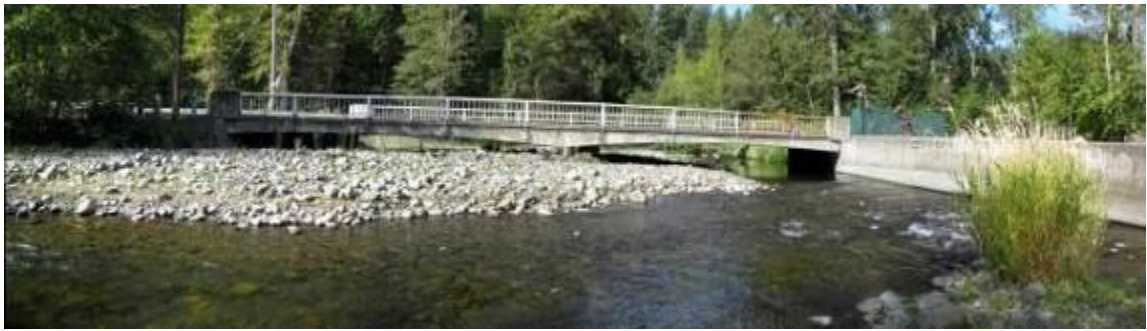
(figure 25) After the stream drops the majority of its bedload at this site, Mill Creek flows under the bridge and the stream channel gradient begins to progressively steepen throughout the assessment reach, as indicated in the stream longitudinal profile in figure 26. Without fully knowing the history of the Mill Creek assessment reach stream channel, there are three possible reasons for this increase in gradient. The Wickersham Bridge acts as a sediment trap, and may be causing increased erosion of channel sediments downstream of the bridge, steepening the channel gradient. This is because the greater the sediment supply, such as the area upstream of the bridge, then the more room is required for sediment storage, as we observed. Conversely, if the sediment supply is cut off below the bridge, the stream channel will tend to degrade and steepen. Another reason may be due to the fact that channel manipulations over time have led to a steeper channel through this reach. Past management such as channel straightening and channelization has kept the Mill Creek channel up against the western side of the valley. This was done to protect homes and the Mill Creek Road to the east. Because of this the Mill Creek channel does not move laterally as it did historically. To compensate, the channel has found sediment to carry by down-cutting and becoming steeper through the reach. The third possible reason may be that underlying bedrock plays a role in the steeper gradient. As the channel has adjusted to the human changes that have occurred to it over time, the bedrock underlying the valley has been exposed in places and is acting as a control on channel gradient. These factors are the primary forces driving channel morphology and sediment transport throughout the reach. The differences in the sediment transport properties throughout the reach are discussed in the section on sediment.

Figure 25. Photo of upstream sediment deposition as a result of flow constriction created by the Wickersham Bridge, Mill Creek, Walla Walla County, Washington

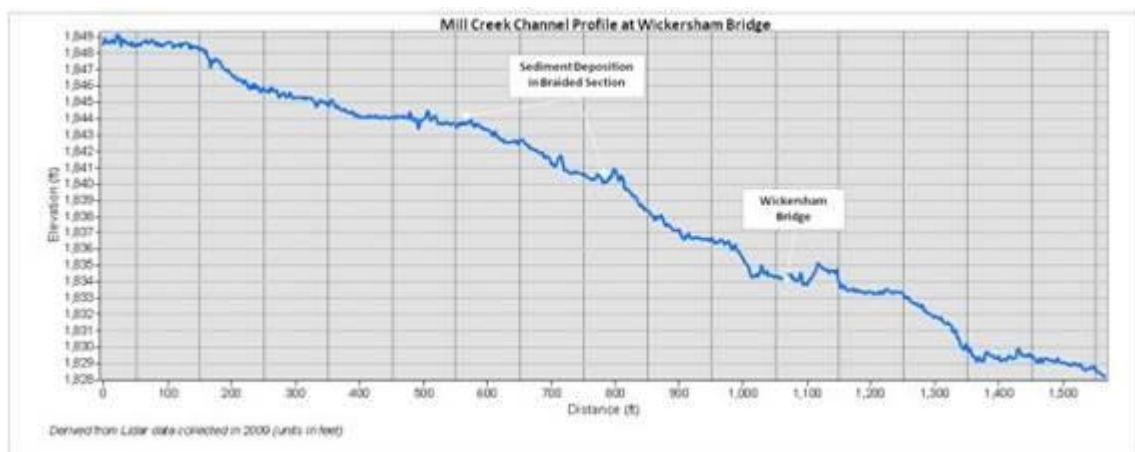
Figure 26. Channel profile, derived from LiDAR data flow in September of 2009 during the low flow period, of Mill Creek above and below the Wickersham Bridge

Note: Observe the location of the artificial sediment trap above the Wickersham Bridge and subsequent steepening of the channel below the bridge.

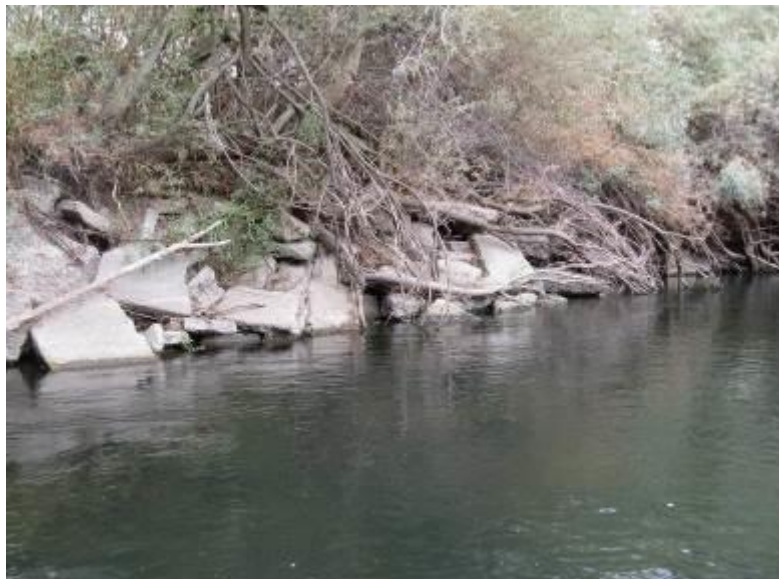
Figure 53. Concrete rip-rap along the channel banks offers little fish habitat; Walla Walla County, Washington

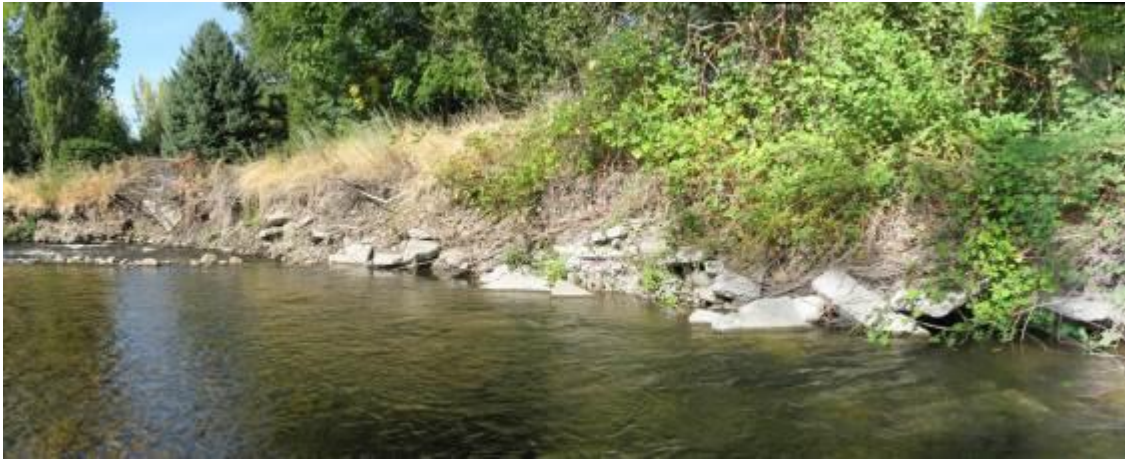
Figure 54. Concrete rip-rap along the channel banks offers little fish habitat; Walla Walla County, Washington

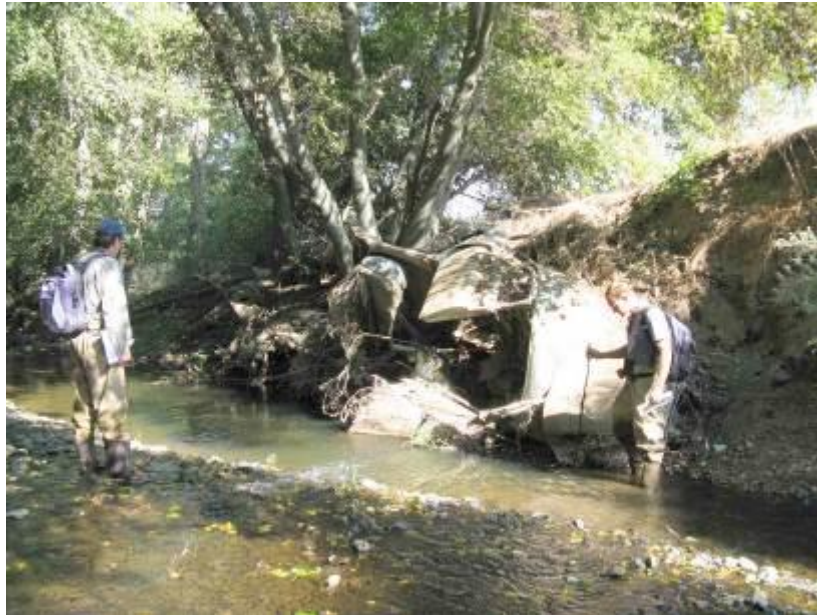
Figure 55. Car body placed in channel presumably to prevent erosion; Walla Walla County, Washington
