**Walla Walla County Conservation  
District**

**Byerley Screen  
Cottonwood  
Creek**

Funded by  
Washington State Conservation  
Commission,  
WDFW Yakima Screen Shop  
&  
Byerley Farms

Walla Walla County Conservation District  
2017

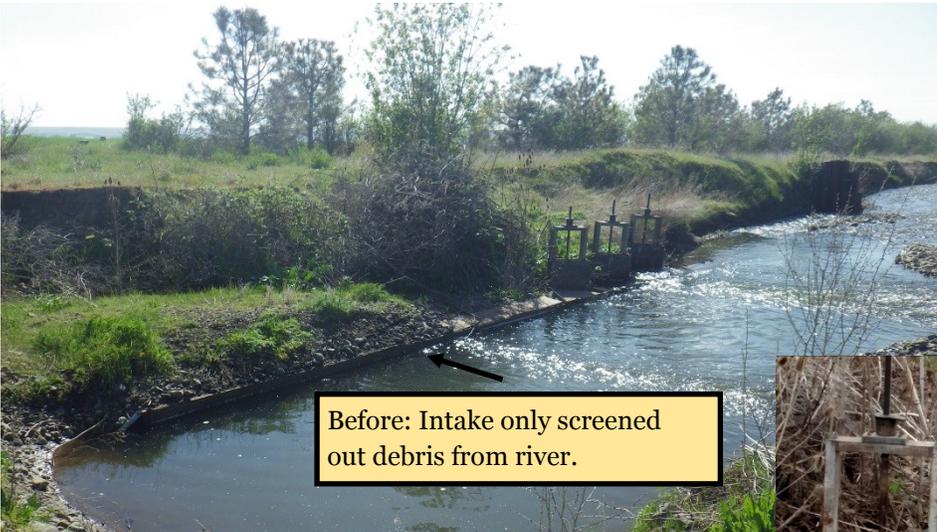
The Byerley Screen Project was a complex and challenging undertaking that required a considerable amount of planning. The project site is located along Cottonwood Creek, which is an intermittent waterway. The irrigation intake led to an irrigation pipe and canal and emptied flow into a pond off the creek. The pond helped with sediment settling and was used for irrigation.

Before: Intake only screened out debris from river.

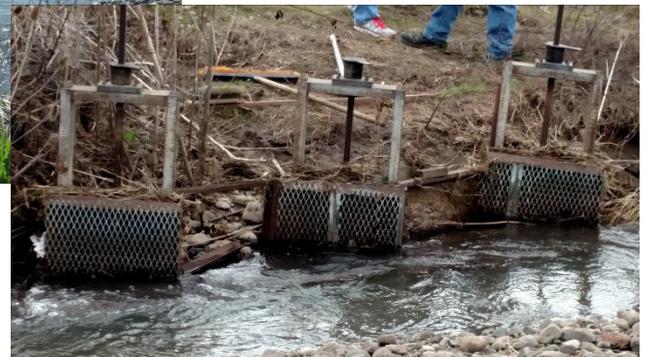
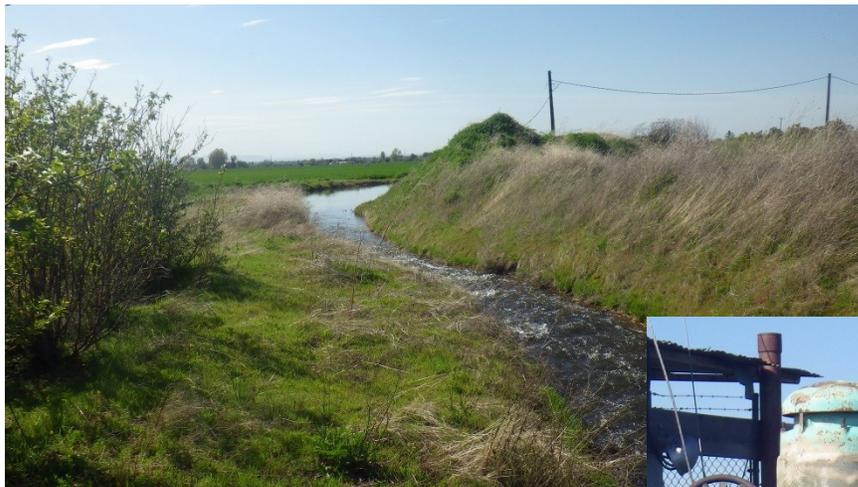
Adult salmonids were somewhat blocked from the system by a grate, but the grate was not a barrier to juvenile fish. When the creek ran dry in the summer months, there was a risk of juvenile fish being stranded.

During high spring flows, fish traveled up this short canal and ended up in the pond. When the pond was full, an overflow structure sent water back to the creek.

The overflow only functioned during high flows when the pond was full. When water levels began to drop, there was no exit for fish.

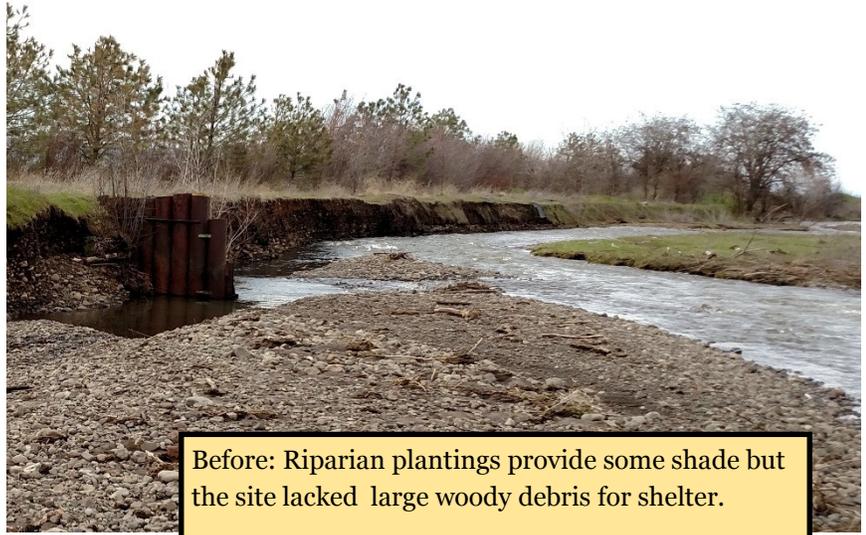
Before: Riparian plantings provide some shade but the site lacked large woody debris for shelter.

There were concerns about the possibility of high flows that could affect the screen site and the lack of habitat in the area. Even though Cottonwood Creek is a seasonal stream that always goes dry in the early summer, it was clear that salmonids were utilizing the creek. The project was expanded to include large woody debris placement to protect the screen and improve habitat.

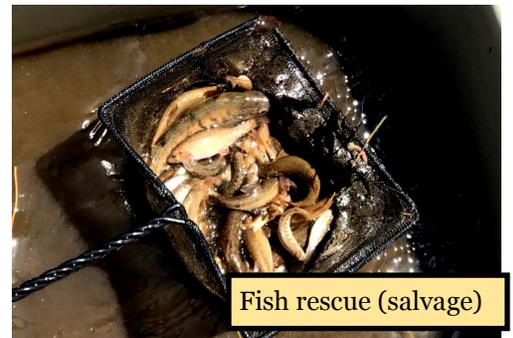
As soon as Cottonwood Creek entered its seasonal dry phase, the project began. Just prior to construction, 191 salmonids and over 300 fresh water fish were removed from the pond and canal and

Fish rescue (salvage)

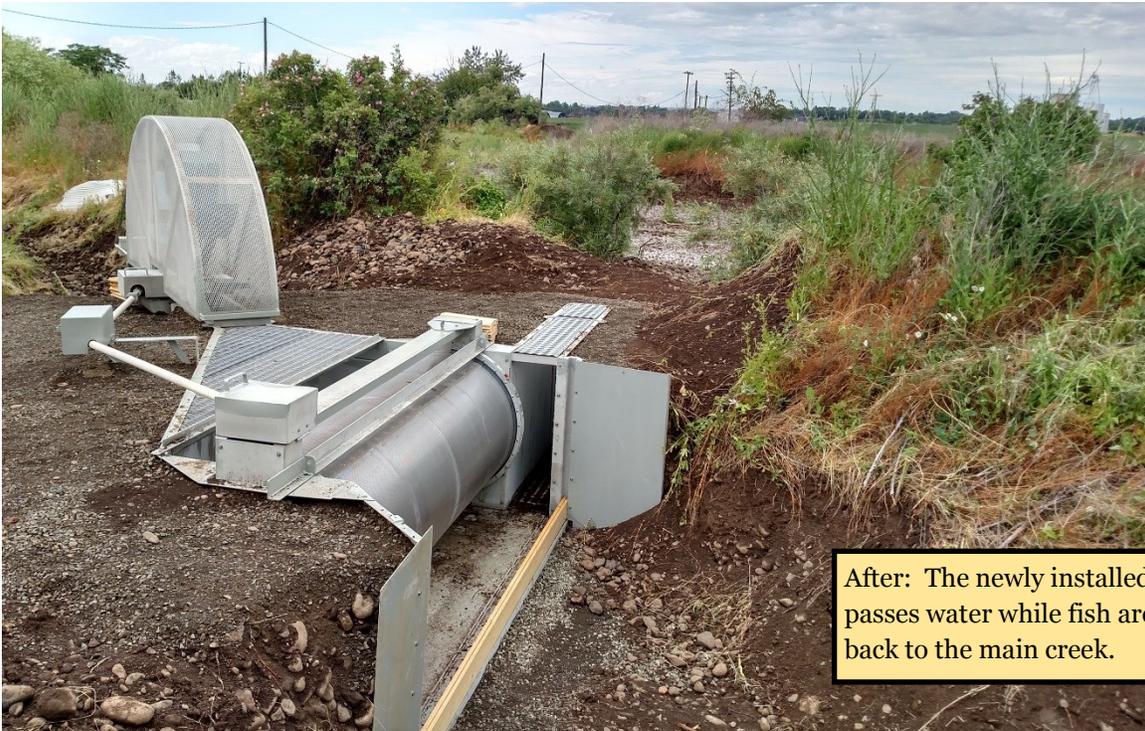
After: The newly installed screen passes water while fish are directed back to the main creek.

WDFW's Yakima Screen Shop supplied and installed a modular single rotary drum screen. The screen meets National Marine Fisheries Service requirements and allows for the 6.6 cfs flow authorized by the Byerley Farm spring water right.

The new rotating drum screen is much more efficient than the old grate system and completely screens the intake. Thanks to the new screen, fish are kept out of the pond completely so there is no concern that fish will be stranded there.

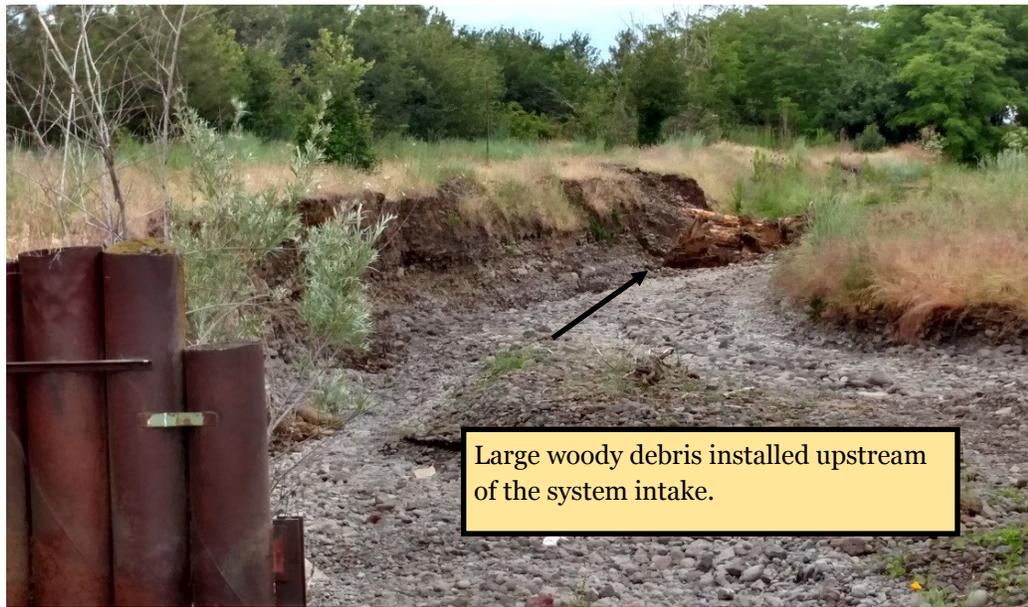
Large woody debris installed upstream of the system intake.

Then several large woody debris structures were installed in the south bank of Cottonwood Creek between the diversion gates and the mouth of pond. The structures effectively slow down stream flow during times of high water and provide additional shade and shelter in the channel.

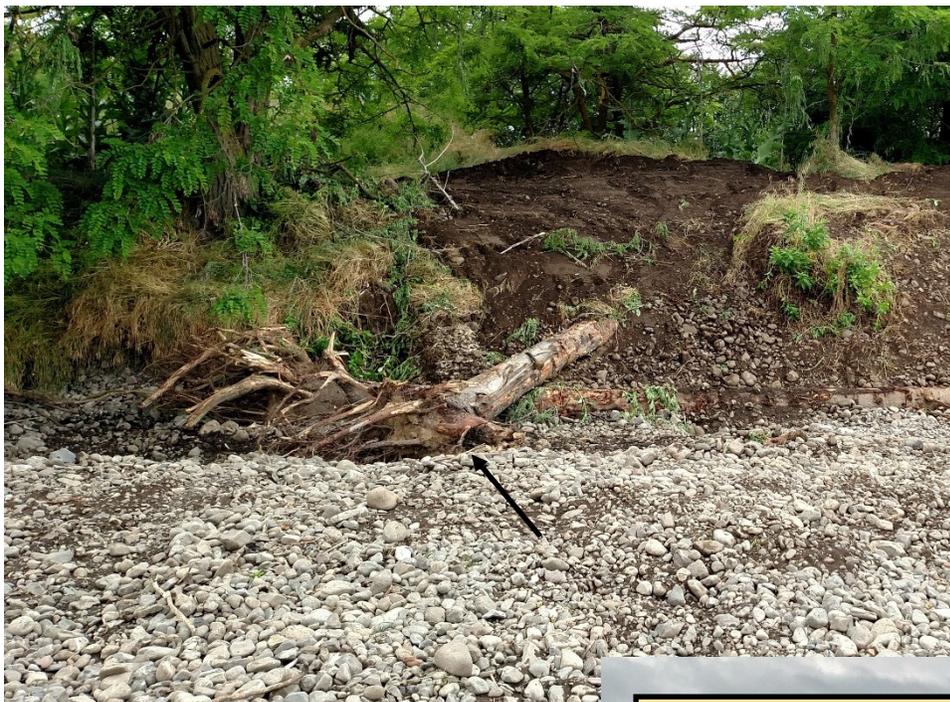
accessible to fish for a short distance but the flow by the screen directs them back to the main creek. A day after project completion, a significant rain event gave staff a chance to observe that the screen was functioning perfectly.

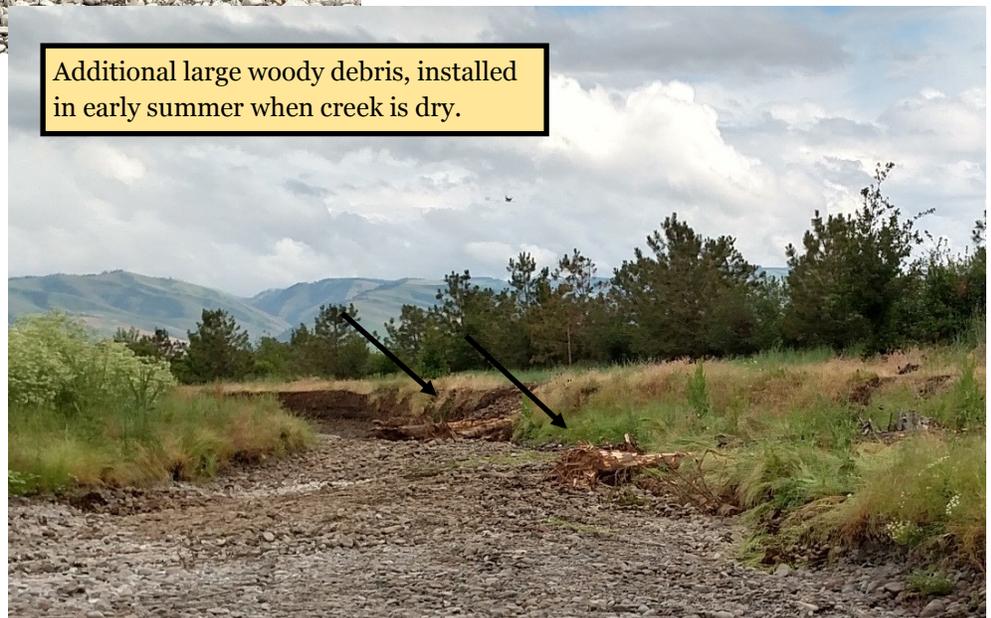
Additional large woody debris, installed in early summer when creek is dry.
