Final Report

MCCAW REACH FISH RESTORATION PHASE B

2015 - 2018

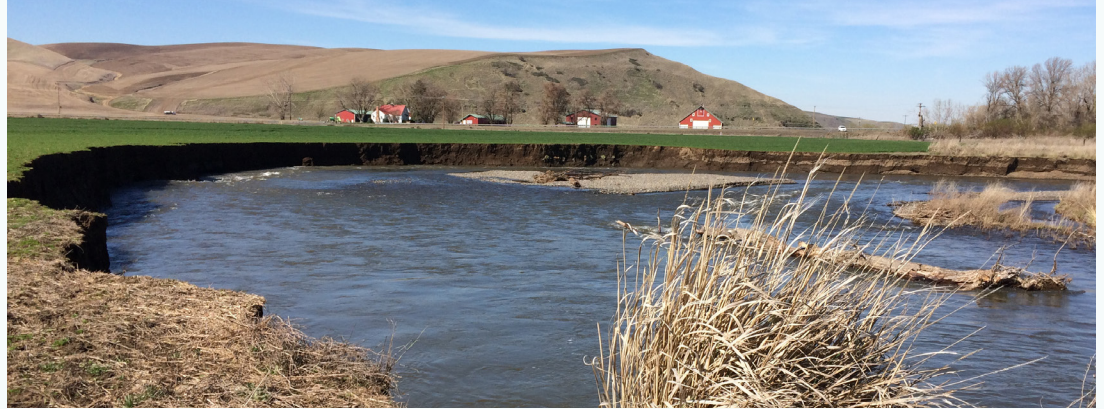
Westernmost oxbow bank erosion. Looking downstream spring of 2016.

When construction began in 2018, the site was characterized by an over-straightened channel with minimal roughness and complexity. Severe erosion of the south bank was causing the river to cut into the adjacent agricultural field. The river in this reach was a single shallow channel that was over-widened with few pools, few cover or resting areas, and with a minimal potential to recruit or hold large wood. The result was poor salmonid habitat and significant loss of productive farmland.

The sharply eroded bank (pictured previous page) now forms a less severe 45 degree angle and is reinforced with 10 log jam structures topped with gravel. Along this bank as well as the bank of the main channel, willow whip plantings may further retain sediment as well as grow and shade the river.

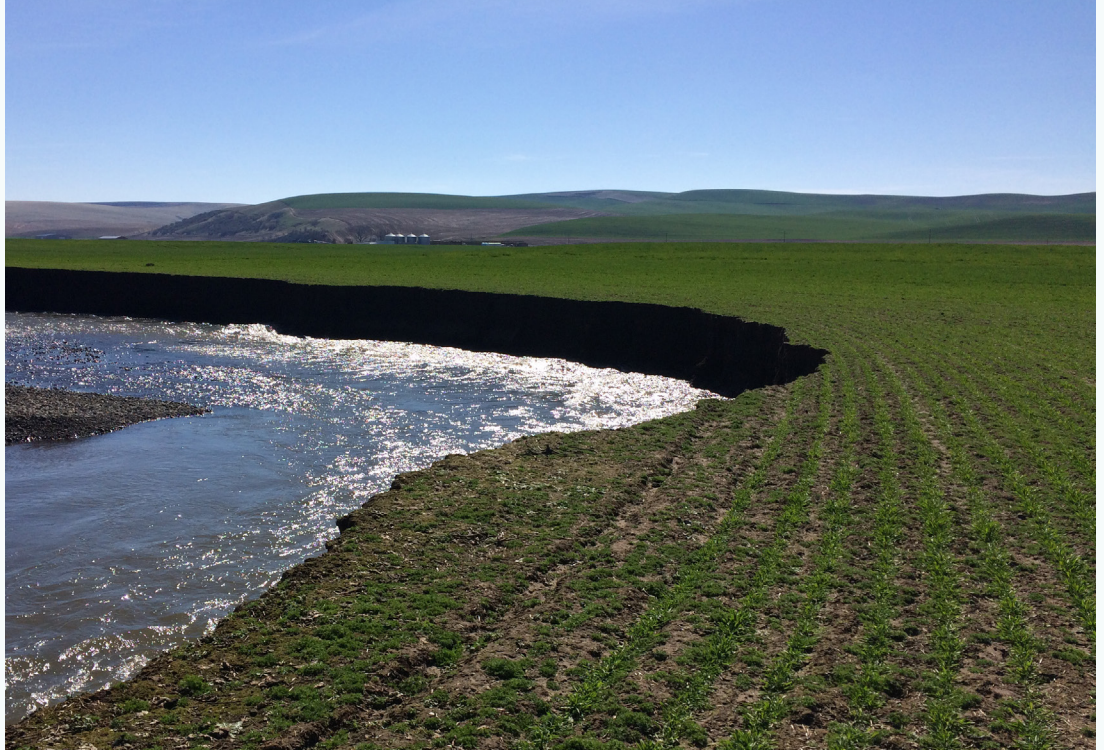
Westernmost oxbow bank erosion. Looking upstream spring of 2016.

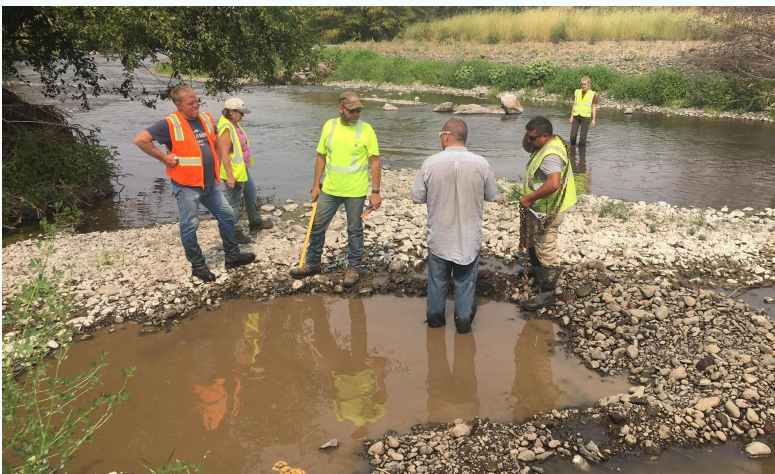
Engineer, machine operator, and workers discuss limitations of anchoring LWD structures into bedrock.

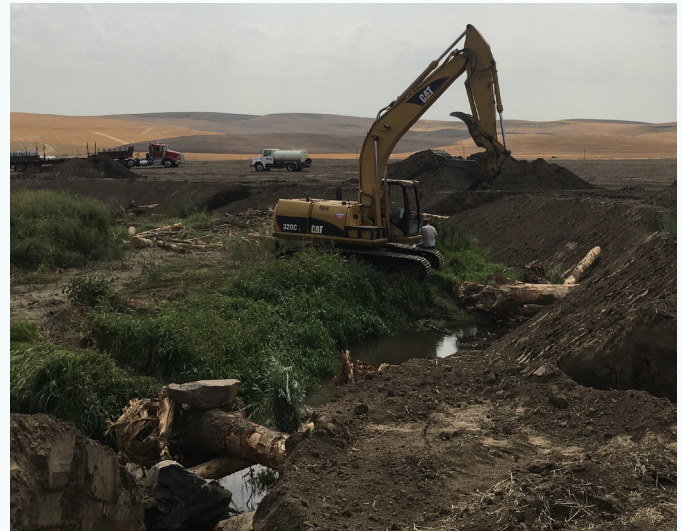
Reshaping the high-water channel.

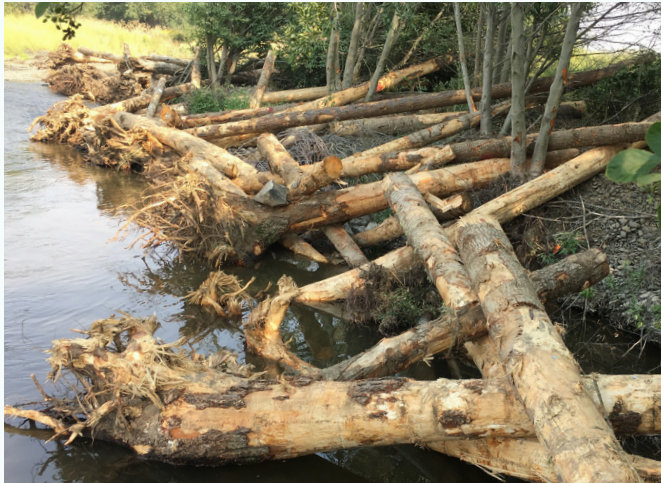
Multi-log LWD along the main channel.

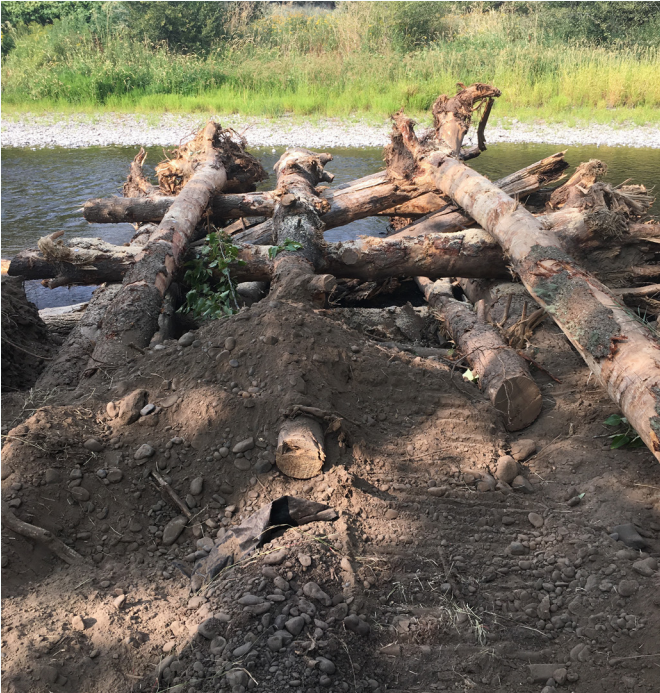
Completed Bank ELJ.

One Box ELJ and two Bank ELJs were built in the Phase B project. These structures are different in form but similar in function as they all are intended to mimic a log jam. These structures are intended to collect and shed woody materials that are moving within the system. Some structures like the Box ELJ helps form channels and promote side channel flow, while others are more suited to provide pool habitat, high flow refuge, escapement cover, and promote local deposition.

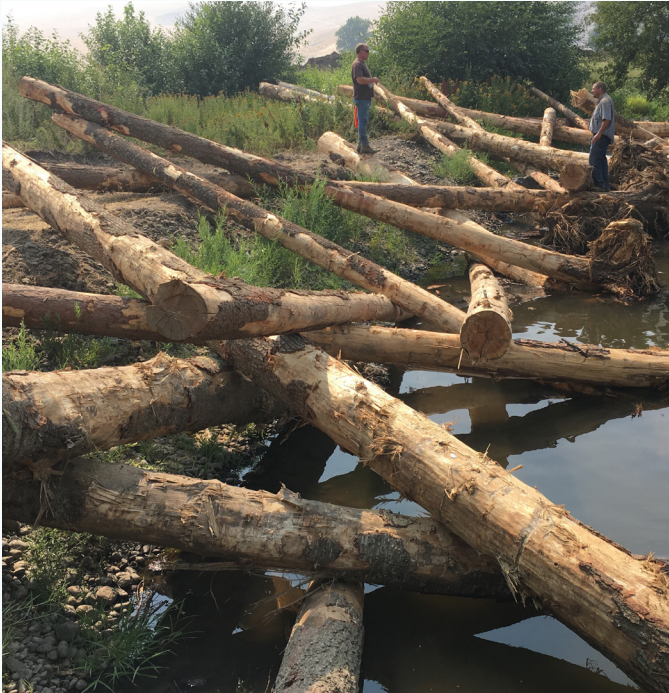
Completed Multi-log LWD before replanting.

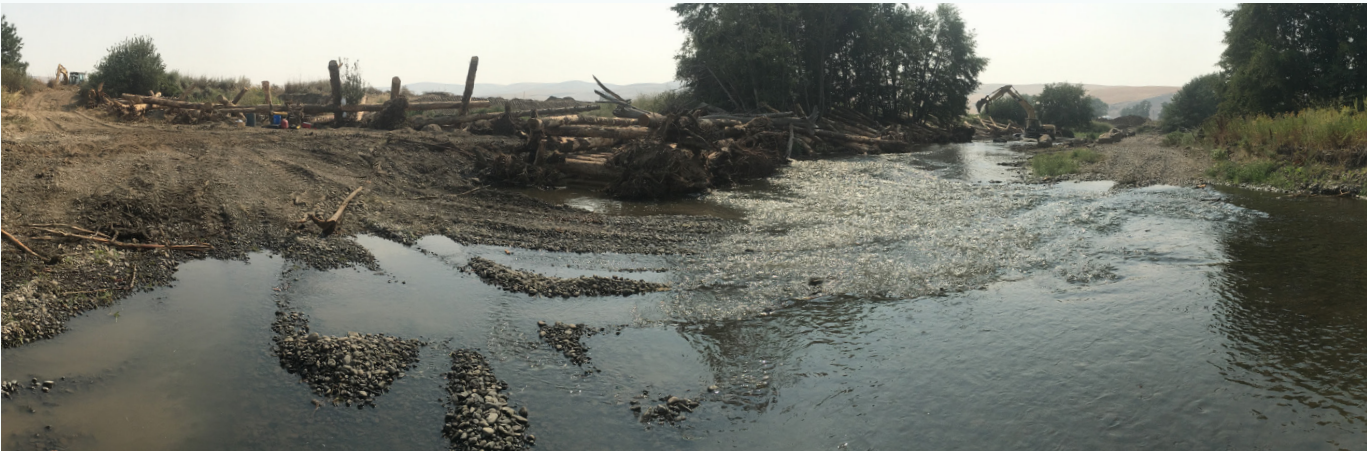
Looking downstream: Pictured left is the Channel Spanning Structure, to the right is the main channel and Multi-log LWD.

The Channel Spanning Structure extends the full width of the site's side channel and helps divert water away from the side channel during low flow periods, but allows water to enter during a high flow period.

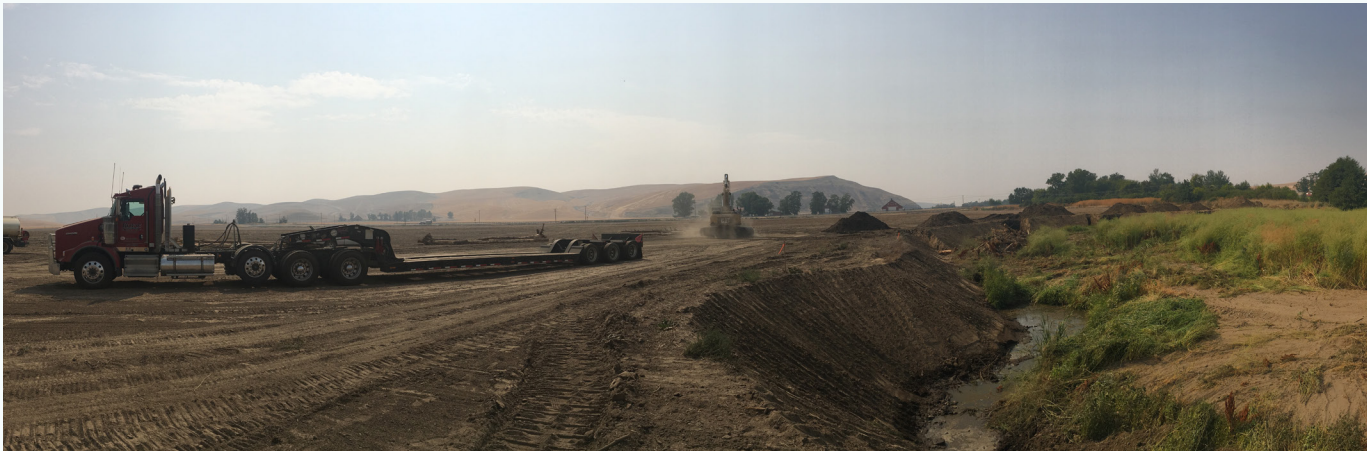
Gravel delivery and bank reshaping.
