May 2010

Walla Walla River, Mill Creek, and Coppei Creek Geomorphic Assessment

Walla Walla County Conservation District and
U.S. Forest Service, TEAMS Enterprise Unit

Compiled: April, 2010; Revised: May 2010

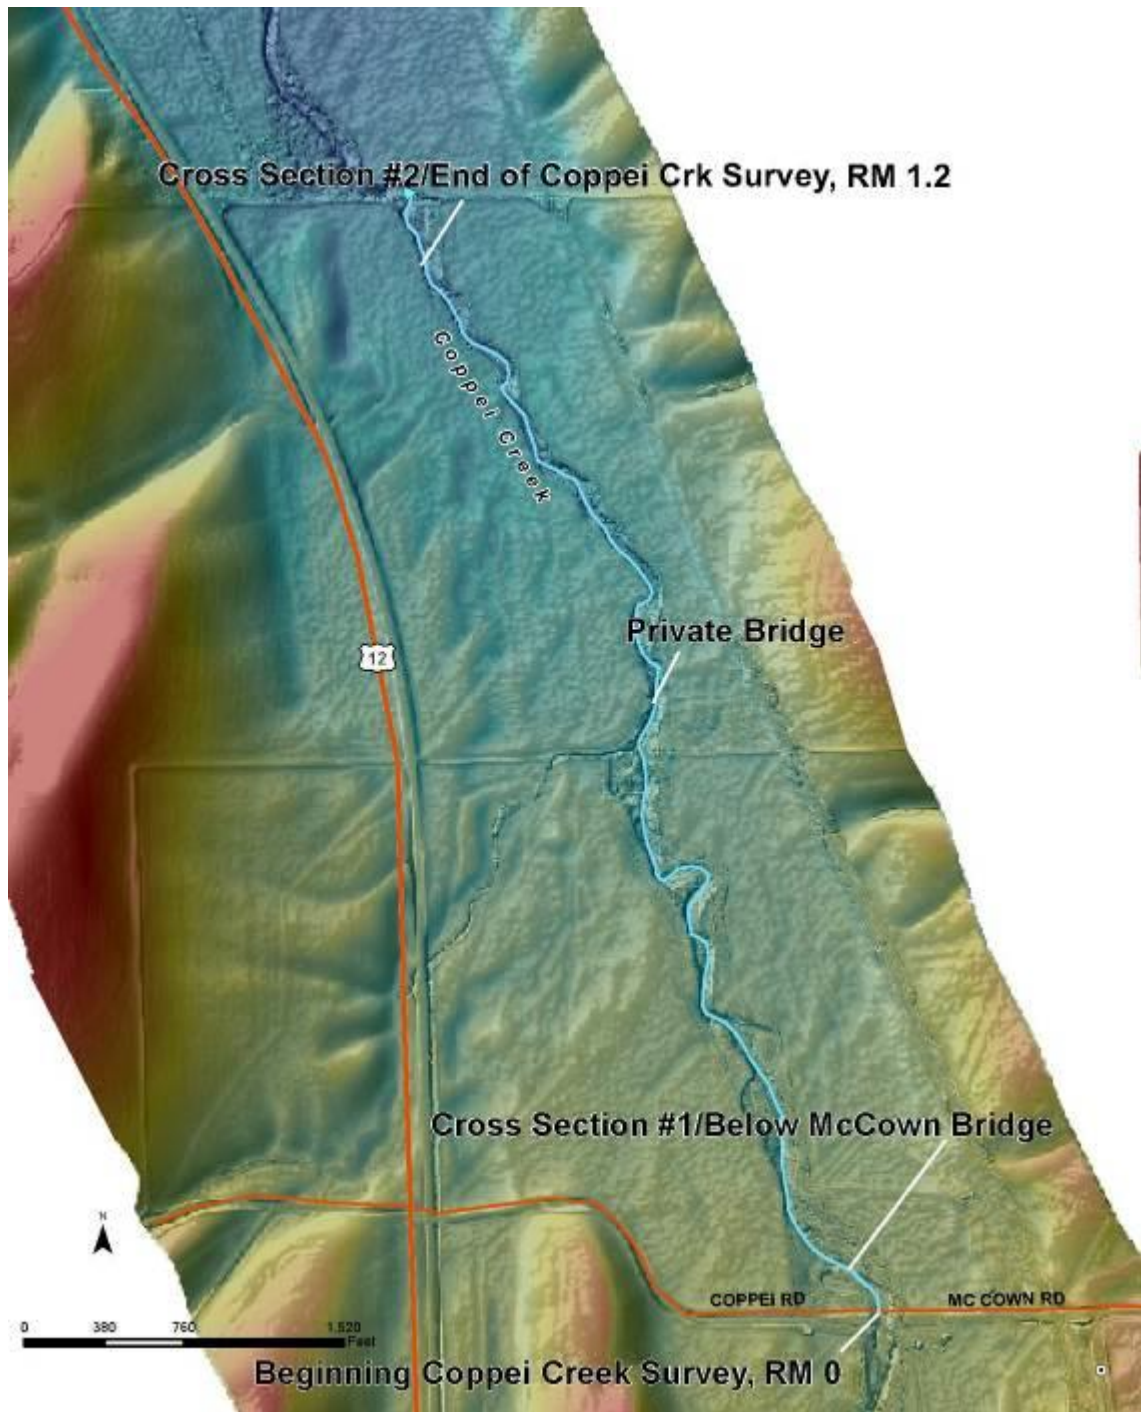
Figure 20. Coppei Creek assessment area map

The Coppei Creek assessment reach is approximately 1.2 river-miles long. The reach initiates at the McCown Road Bridge at river mile 0 and flows from the south to the north/northwest until it reaches the antique car lot on the Laverne Filan property at river mile 1.2. Coppei Creek has been channelized throughout this reach and, thus, is highly entrenched. A riparian forest with a width of between 50 and 230 feet is located along the reach. A portion of the riparian area includes about 75 feet-wide streamside buffer plantings implemented in 1999 through the Farm Service Agency (FSA) Conservation Reserve Enhancement Program (CREP). Agricultural lands are located beyond the riparian buffer. There is a private bridge located at RM 0.7. See figure 20 for a map of the assessment reach.

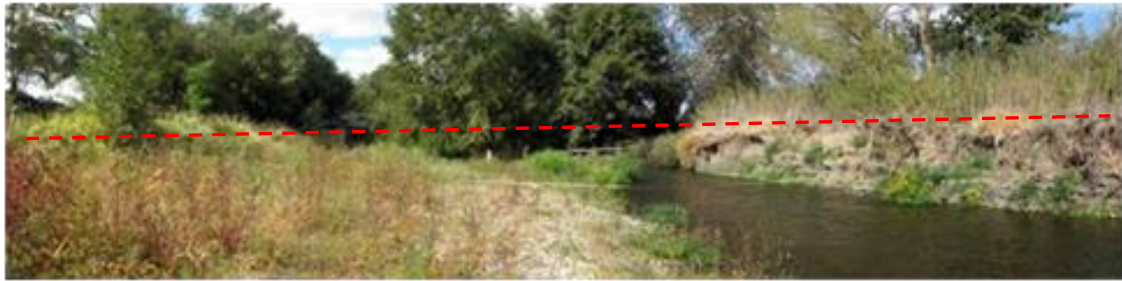
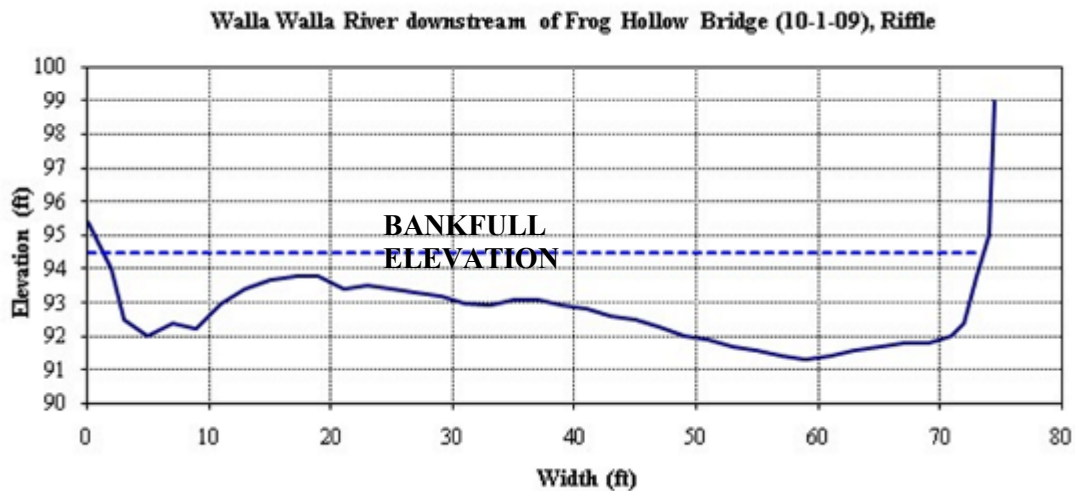
Figure 22. Channel cross-section below the Frog Hollow Bridge, Walla Walla River, Walla Walla County, Washington

The upstream cross-section is located at a riffle approximately 125 feet below the Frog Hollow Bridge. The river slope is 0.3 percent, entrenchment is 4, and the bankfull width-to-depth is 37. Streambed material in this area is all composed of alluvium transported by the stream. The D50 and D84 of the surface stream substrate are 41 and 63 millimeters, respectively. With the slightly entrenched channel in this location, the channel is able to spread out during flooding and access the floodplain easily during high flows (see figure 22).

The cross-section below the Frog Hollow Bridge indicates a channel with a relatively well established floodplain (figure 22), with a width-to-depth ratio at bankfull of 37, a bankfull channel width of 72 feet, an average bankfull depth of 1.9 feet and entrenchment ratio of 4 and a channel slope of 0.3 percent. The Last Chance Bridge cross-section is similar to the Frog Hollow site in that it has a relatively well established floodplain (figure 23). However, the width-to-depth ratio of 39, the bankfull channel width of 85 feet, the average bankfull depth of 2.2 feet, and the channel slope of 0.4 percent are all slightly higher than the upstream cross-section. This data indicates that the Last Chance Bridge site becomes slightly more entrenched at 3, which increases bedload transport at higher flows. The sinuosity overall for the Walla Walla River assessment reach is 1.4.

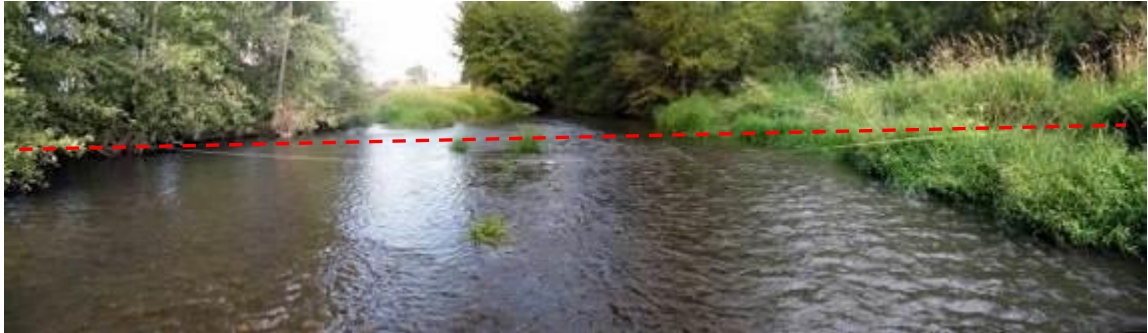
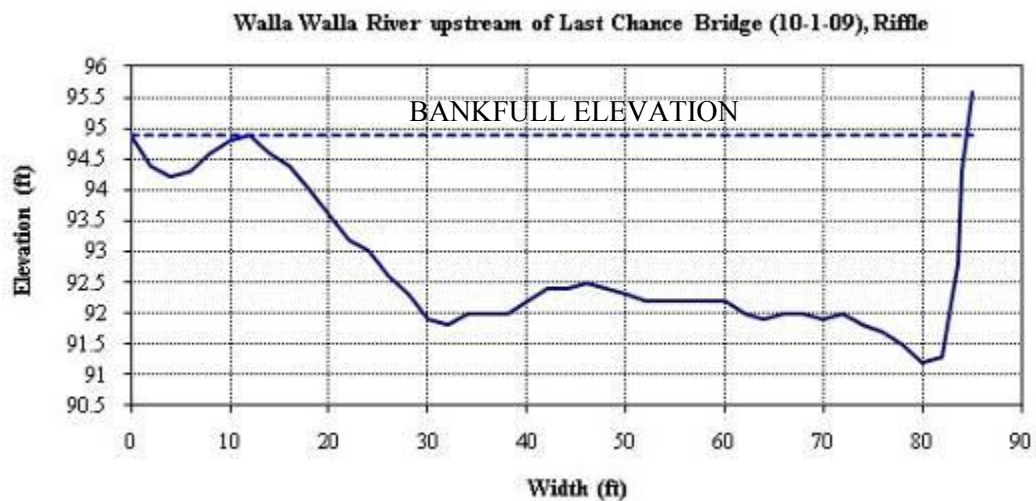
Figure 23. Channel cross-section above the Last Chance Bridge, Walla Walla River, Walla Walla County, Washington

The downstream cross-section was surveyed at a riffle above the Last Chance Bridge at RM 1.6. The river slope is 0.4 percent, the entrenchment is 3, and the bankfull width-to-depth ratio is 39. Streambed material in this area is all composed of alluvium transported by the stream. The D50 and D84 of the surface stream substrate were 45 and 71 millimeters, respectively. With a slightly more entrenched stream channel and a slightly steeper slope in this downstream location, the stream is not able to access the floodplain as much as areas upstream (figure 23).

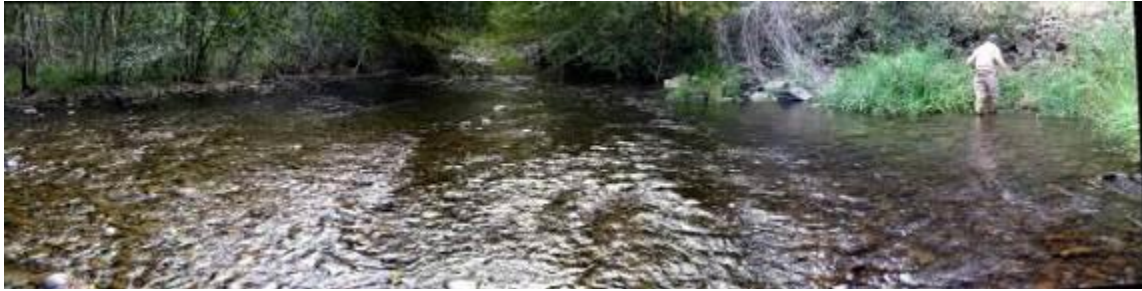
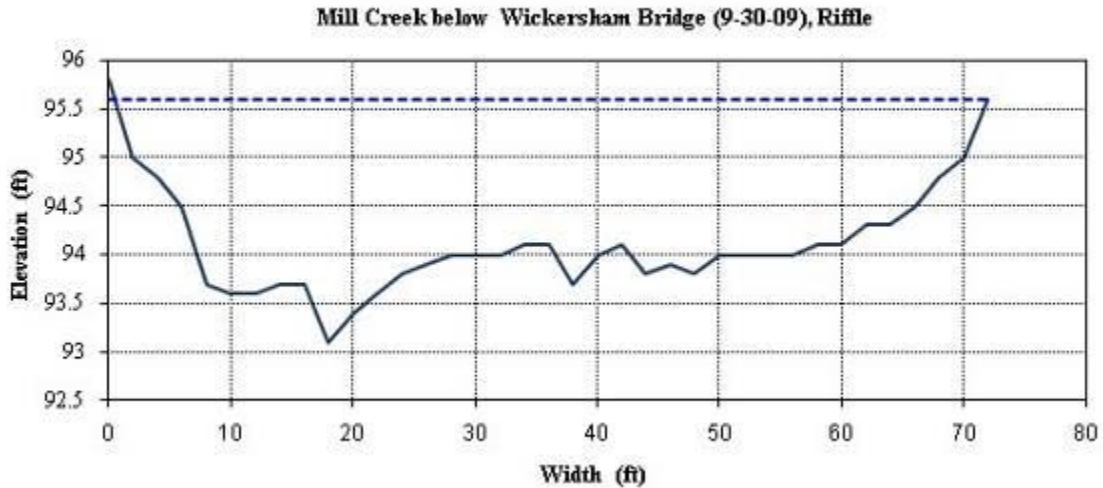
Figure 27. Channel cross-section below the Wickersham Bridge, Mill Creek, Walla Walla County, Washington

The upstream cross-section is located at a riffle approximately 300 feet below the Wickersham Bridge. The river slope is 0.4 percent, entrenchment is 3, and the bankfull width-to-depth is 47. Streambed material in this area is all composed of alluvium transported by the stream. The D50 and D84 of the surface stream substrate were 63 and 131 millimeters, respectively.

The cross-section below the Wickersham Bridge indicates a slightly entrenched stream channel at 3, with a width-to-depth ratio at bankfull of 47, a bankfull channel width of 72 feet, an average depth of 1.5 feet and a channel slope of 0.4 percent. Mill Creek above the Blue Creek confluence cross-section has similar channel morphology as the Wickersham Bridge cross-section with a width to depth ratio of 42, a channel width of 64 feet, and an average depth of 1.5 feet. However, the cross-section above the Blue Creek confluence has a slope of 0.7 percent, indicating that as the channel moves downstream it becomes gradually steeper. This is also the case for the cross-section below the Blue Creek confluence. The channel morphology is similar to the two upstream cross-sections as the channel has a width-to-depth ratio of 48, a channel width of 64 feet, and average depth of 1.3 feet. However, the slope increases to 1.5 percent below the Blue Creek confluence. This is the steepest channel slope throughout the entire assessment reach. The sinuosity for the entire reach is 1.1. The assessment team suggests that this steepening of the stream gradient in the lower part of the assessment reach is a result of years of channel straightening, in-stream large wood removal, ad hoc levee construction, bulldozing of channels, and other river alterations throughout the assessment reach.

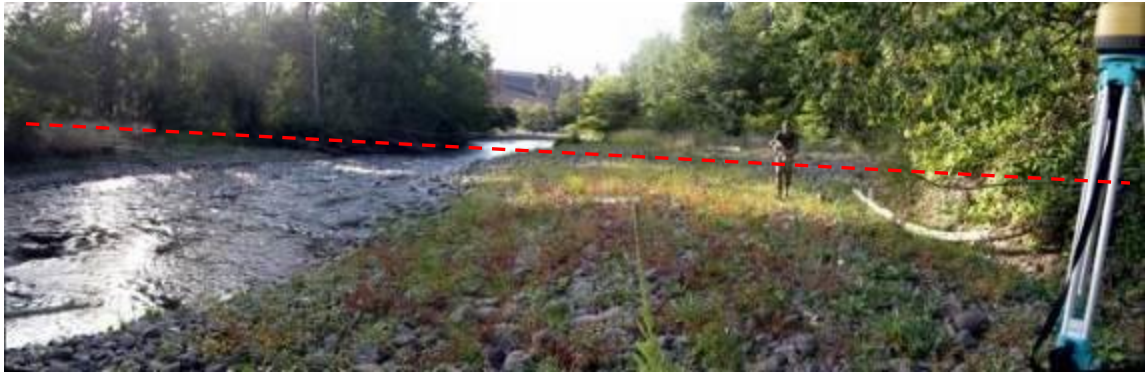
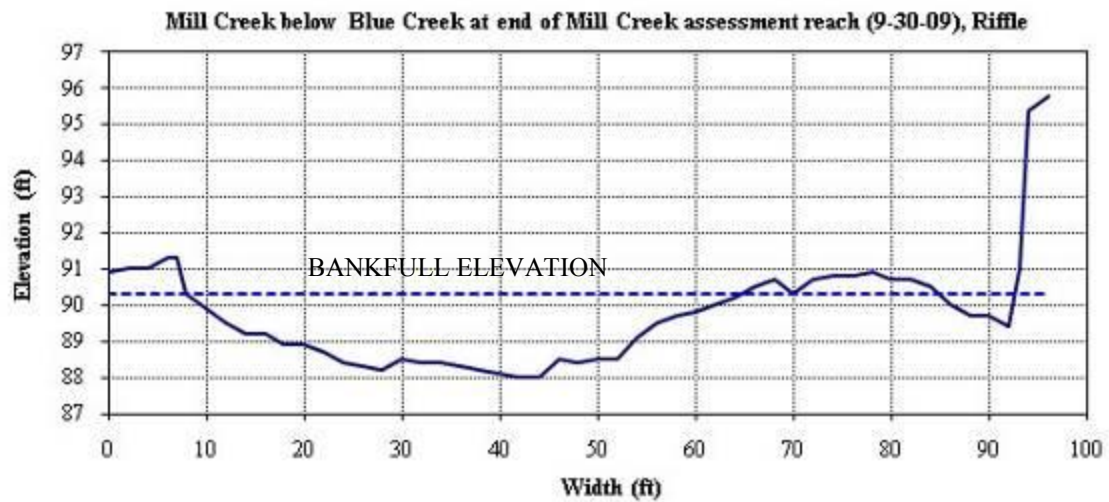
Figure 28. Channel cross-section below the Blue Creek confluence, Mill Creek, Walla Walla Country, Washington

The downstream cross-section was surveyed at a riffle below the confluence with Blue Creek at RM 3.2. The river slope is 1.5 percent, the entrenchment is 3, and the bankfull width-to-depth ratio is slightly more than the Wickersham Bridge cross-section at 48. Streambed material in this area is all composed of alluvium transported by the stream. The D50 and D84 of the surface stream substrate were 58 and 117 millimeters, respectively, and are slightly finer than the Wickersham Bridge cross-section.

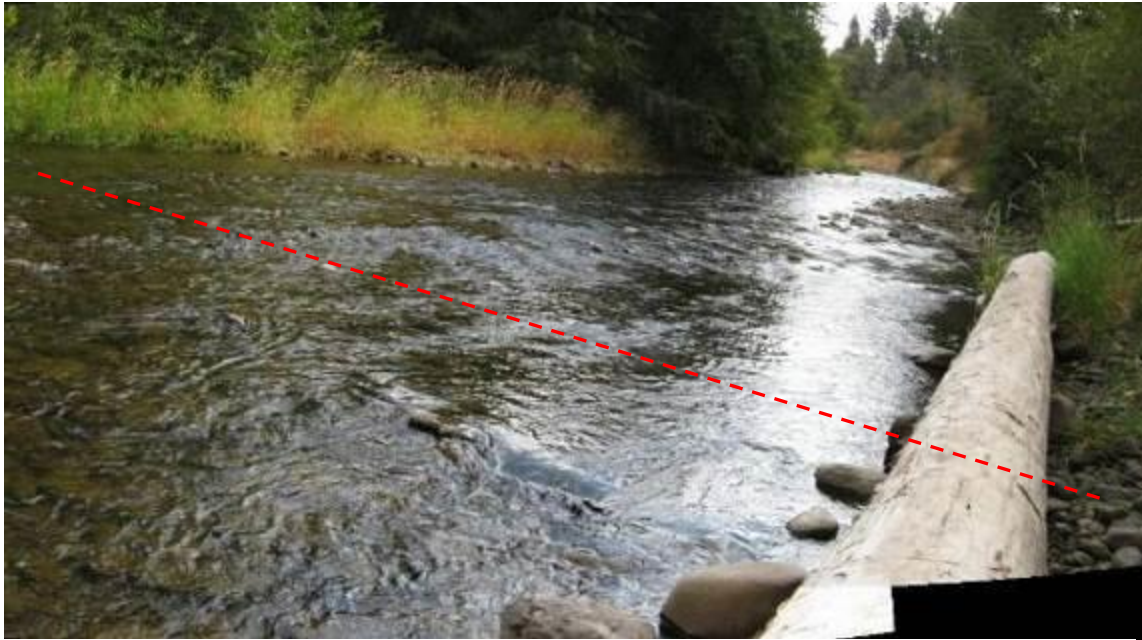
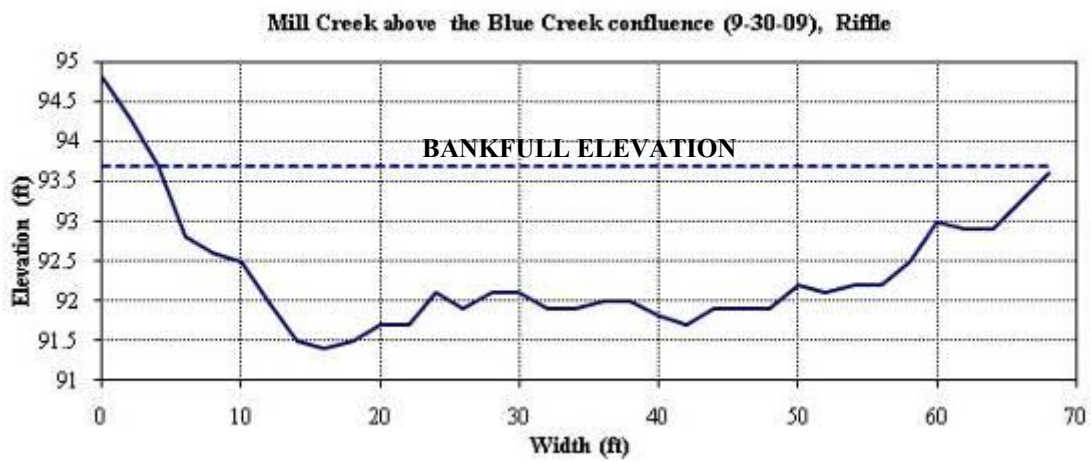
Figure 29. Channel cross-section above the Blue Creek confluence, Mill Creek, Walla Walla County, Washington

In addition to the upper and lower cross-sections taken for Mill Creek, an additional cross-section was taken above the confluence with Blue Creek to show how Blue Creek impacts the Mill Creek stream channel downstream. This cross-section was surveyed at RM 1.5. The river slope is 0.7 percent, the entrenchment is 3, and the bankfull width-to-depth ratio is 42, slightly less than that measured in the cross-section below Blue Creek. Streambed material in this area is all composed of alluvium transported by the stream. The D50 and D84 of the surface stream substrate were 67 and 121 millimeters, respectively; similar to both the Wickersham Bridge and below the Blue Creek confluence cross-section.

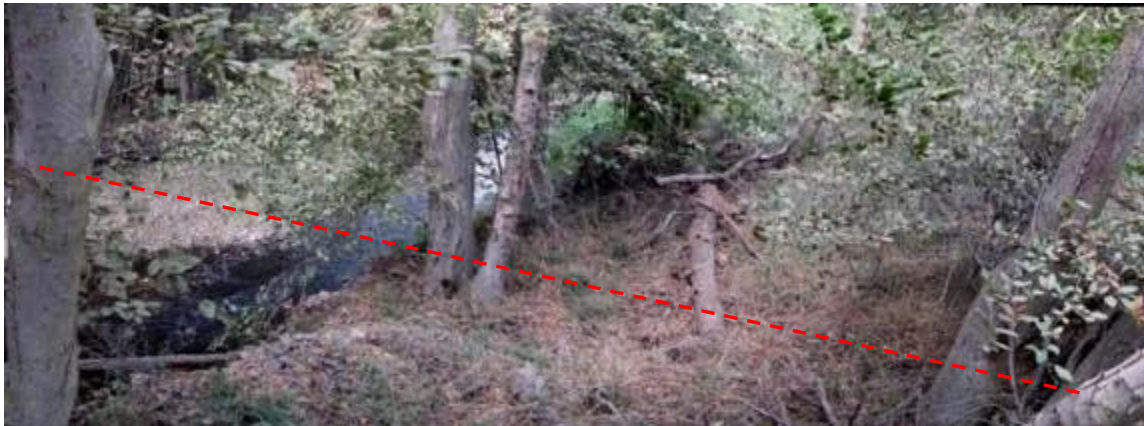
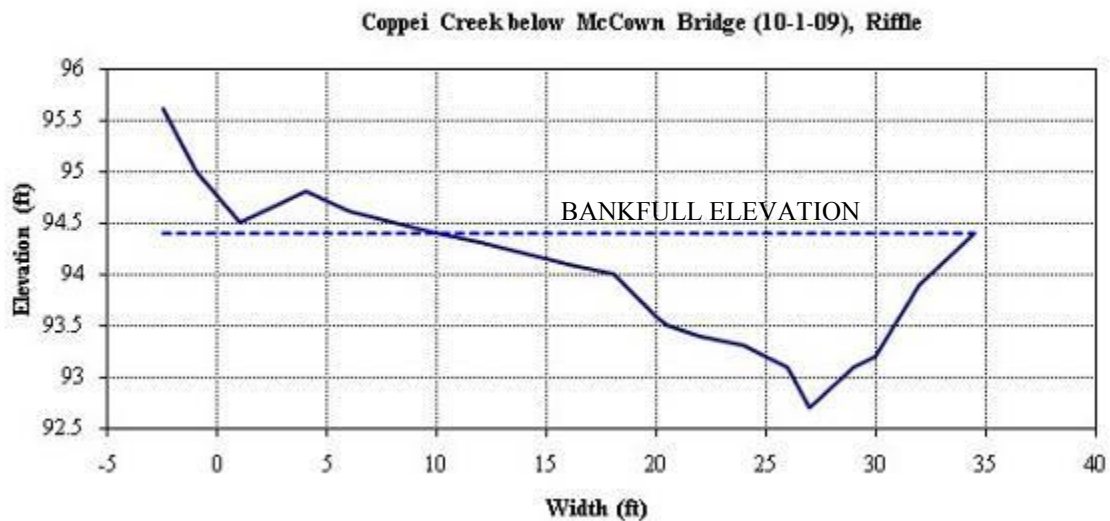
Figure 30. Channel cross-section below the McCown bridge, Coppei Creek, Walla Walla County, Washington.

The upstream cross-section is located at a riffle 300 feet below McCown Bridge. The river slope is 2.2 percent, entrenchment is 2, and the bankfull width-to-depth is 35. The entrenchment ratio is indicative of a moderately incised stream channel (figure 30). Streambed material in this area is composed of alluvium transported by the stream. The D50 and D84 of the surface stream substrate was 34 and 78 millimeters, respectively.

Both cross-sections indicate a stream channel that has recently down-cut due to past land use impacts (channelization). Entrenchment values indicate a channel with a limited flood storage capacity. Because of this, increased flows are more apt to cause excessive erosion and channel migration. Coppei Creek, through this reach, is attempting to adjust back to its natural channel geometry, with a wider floodplain and more meanders. The channel will continue to erode a wider floodplain in the future until it reaches equilibrium to stream discharge and sediment transport regimes.

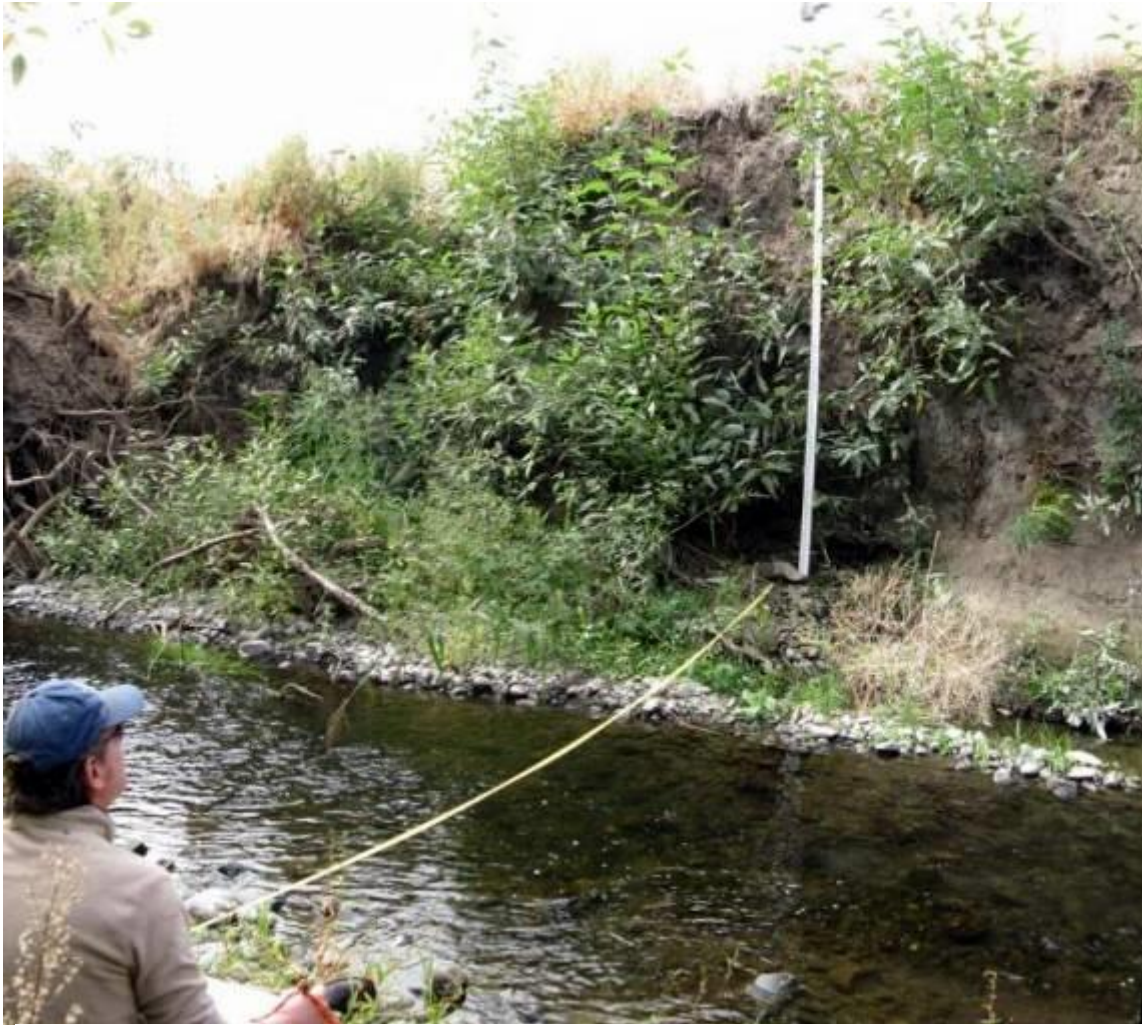
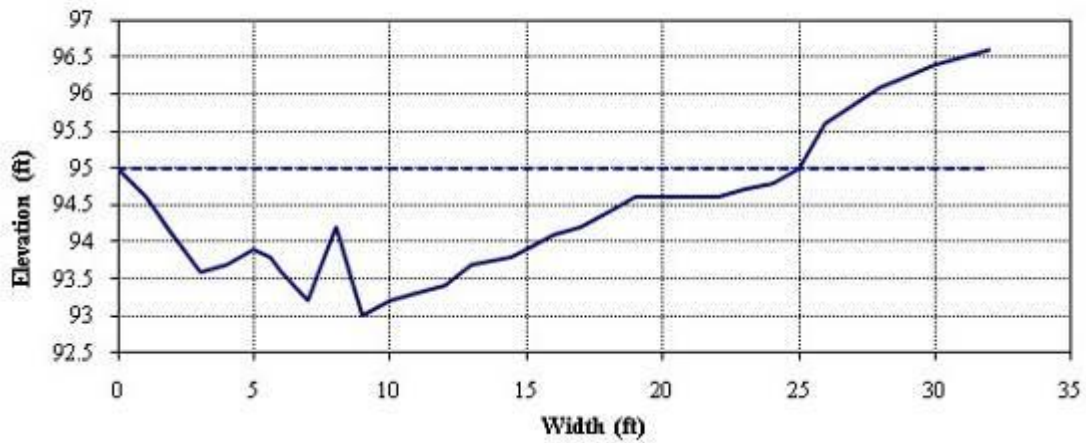
Figure 31. Channel cross-section above the antique car lot at downstream end of assessment reach, Coppei Creek, Walla Walla County, Washington

The downstream cross-section was surveyed in a riffle above the antique car lot property at RM 1.2. The river slope is 1.6 percent, the entrenchment is 1, and the bankfull width-to-depth ratio is 25, similar to the upstream McCown Bridge cross-section. At this cross-section, the entrenchment ratio was indicative of a highly incised stream channel from past channelization of this reach. Streambed material in this area is all composed of alluvium transported by the stream. The D50 and D84 of the surface stream substrate were identical to the McCown Bridge cross-section at 34 and 78 millimeters, respectively.

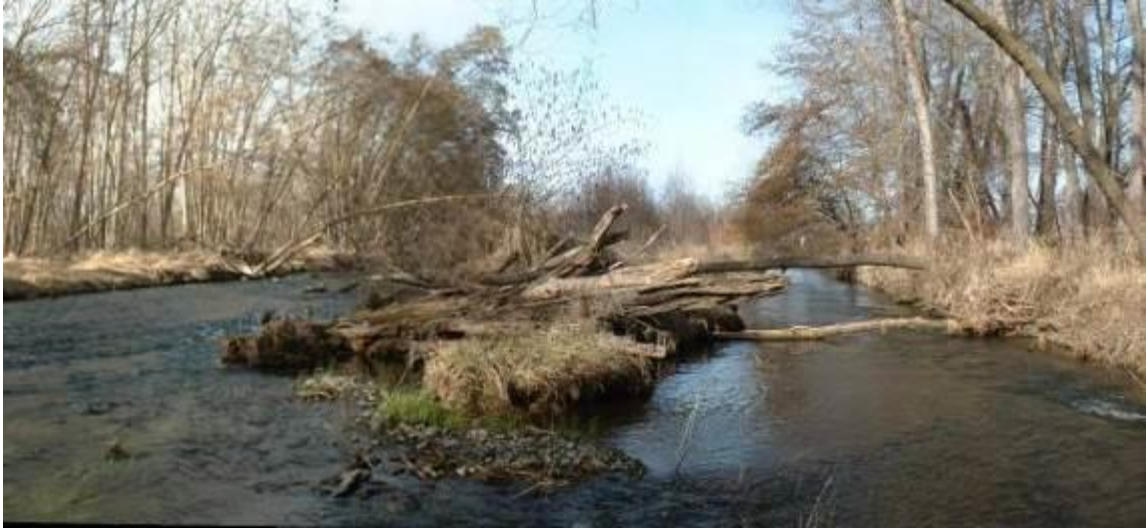
Figure 32. Large wood and channel conditions along the Walla Walla River assessment reach, Walla Walla County, Washington

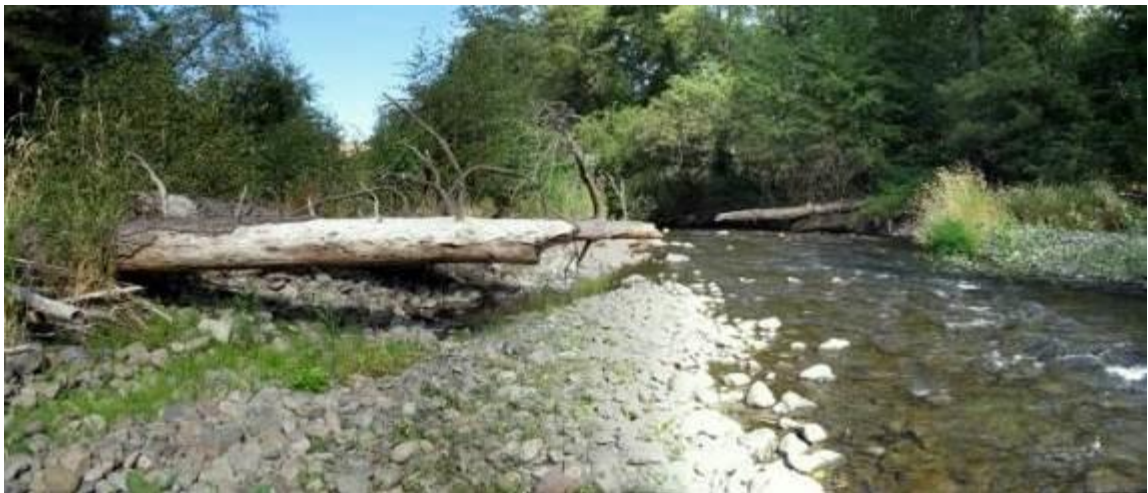
Figure 33. Large wood and channel conditions along Mill Creek assessment reach, Walla Walla County, Washington

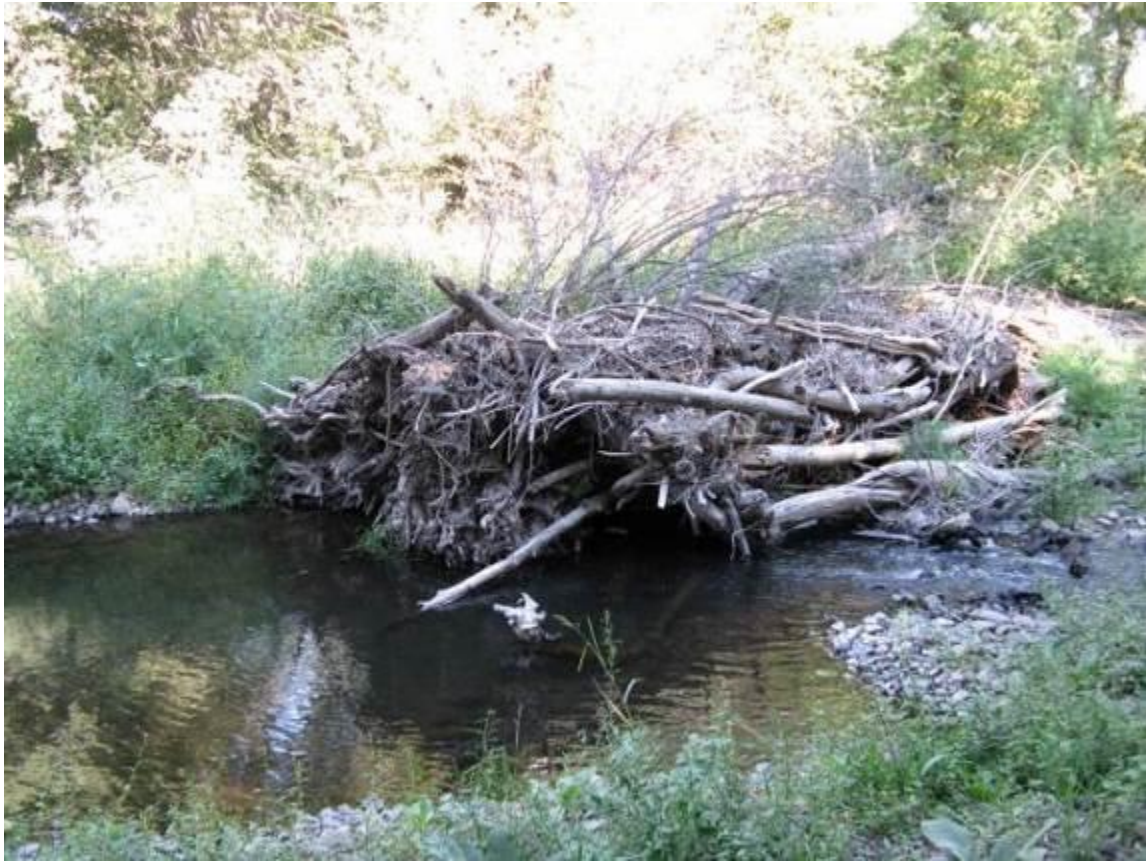
Figure 34. Large wood and channel conditions along the Coppei Creek assessment reach, Walla Walla County, Washington

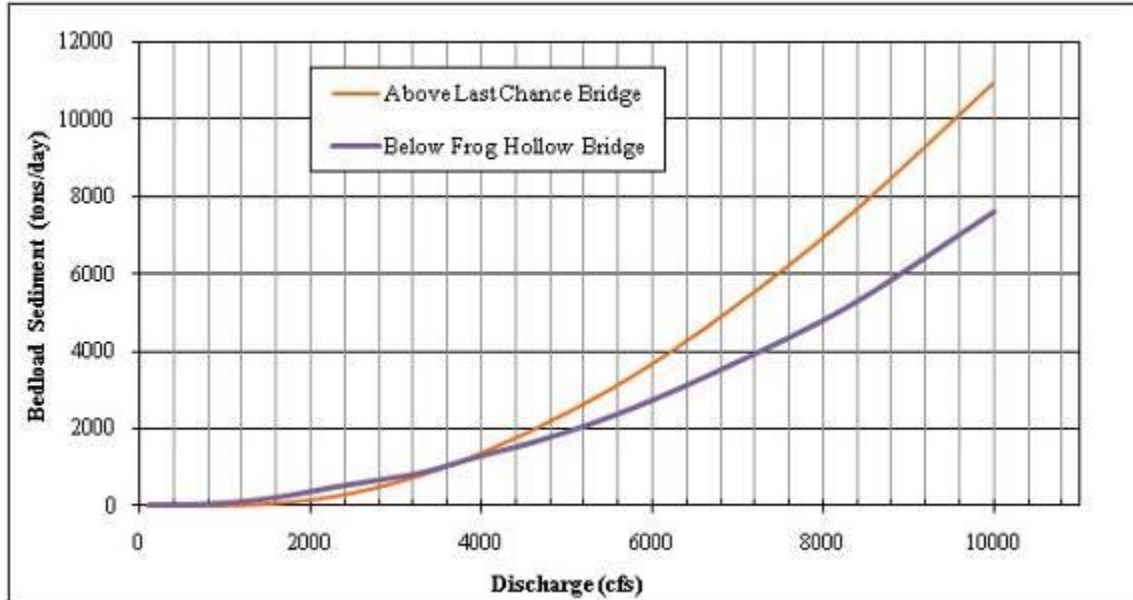
Figure 35. Bedload rating curve, below Frog Hollow Bridge and above Last Chance Bridge during all flows, Walla Walla County, Washington

Estimates of bedload transport for both the Frog Hollow and Last Chance Bridge sites are provided in figure 35, and show that bedload transport initiates at approximately 700 cfs in the Frog Hollow cross-section and approximately 900 cfs in the Last Chance cross-section. Bankfull flow, estimated to be about 732 cfs in the Walla Wall assessment reach, transports about 25 tons per day of bedload at the Frog Hollow site and less than 5 tons per day at the Last Chance Bridge site.

As flows increase, sediment transport increases exponentially, as shown in figure 35. At 8,000 cfs, approximately 4,980 tons per day of bedload is transported through the Frog Hollow reach and 7,230 tons per day through the Last Chance reach. The stream through the Frog Hollow cross-section in the upper reaches of the assessment area is less confined than the downstream Last Chance Bridge cross-section. This would indicate that as the stream gets slightly steeper, deeper and more confined, it has an increased ability to transport sediment introduced from upstream.

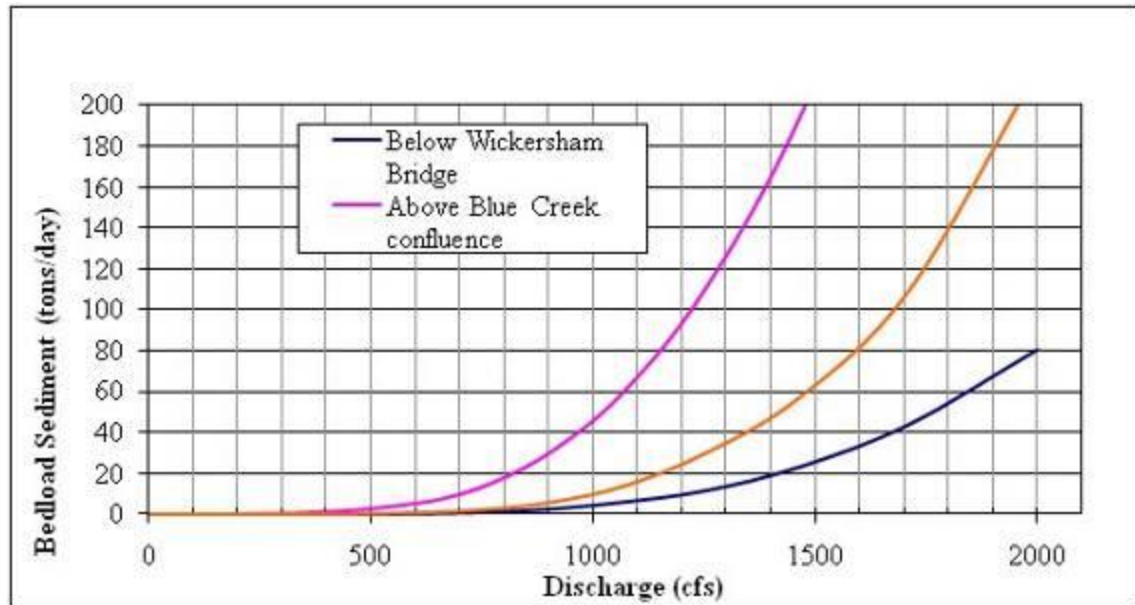
Figure 36. Bedload rating curve, below Wickersham Bridge and above and below the Blue Creek confluence during all flows, Walla Walla County, Washington

As flows increase, sediment transport increases exponentially, as shown in figure 36. At 1,400 cfs, about 20 tons per day of bedload is transported through the Wickersham Bridge site. The cross-section above the Blue Creek confluence has 160 tons per day transported through at 1,400 cfs while the cross-section below the Blue Creek confluence has 45 tons per day transported.

The reason why the site below the Wickersham Bridge does not transport more bedload at bankfull and at higher flows is probably because the channel has a lower channel slope in this location. The bridge upstream and the levee adjacent to the cross-section structures constrict the stream channel, and may play a role in the lower channel slope. Visual evidence shows that the bedload in this reach becomes trapped above the Wickersham Bridge. Figures 25 and 26 (see section “4. Assessment Reach Conditions”) clearly show that the capacity of the Wickersham Bridge is reduced by bedload deposition.

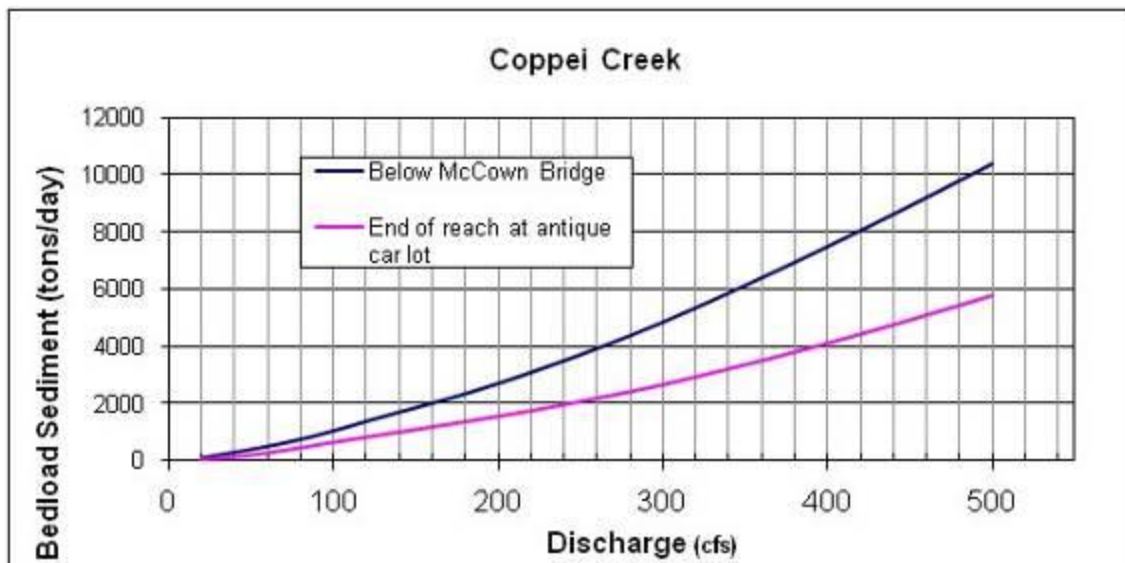
Figure 37. Bedload rating curve below McCown Bridge and above the antique car lot at the end of the assessment reach, Coppei Creek, Walla Walla County, Washington

Estimates of bedload transport for the Coppei Creek cross-sections are provided in figure 37 and show that bedload transport initiates somewhere below 20 cfs, most probably closer to below 5 cfs. Bankfull flow, estimated at this site to be approximately 322 cfs, transports about 5,600 tons per day of bedload at the McCown Bridge cross-section and approximately 3,100 tons per day at the antique car lot cross-section.

As flows increase, sediment transport increases exponentially, as shown in figure 37. At 500 cfs, about 10,300 tons per day of bedload are transported through upper sections of the reach while approximately 5,800 tons per day are transported through the lower sections. As mentioned, the entire Coppei reach is confined, with very little floodplain, so as flows increase the stream gets deeper and has substantially more ability to transport sediment introduced from upstream. Most of the leveed section of Coppei has similar sediment transport characteristics.

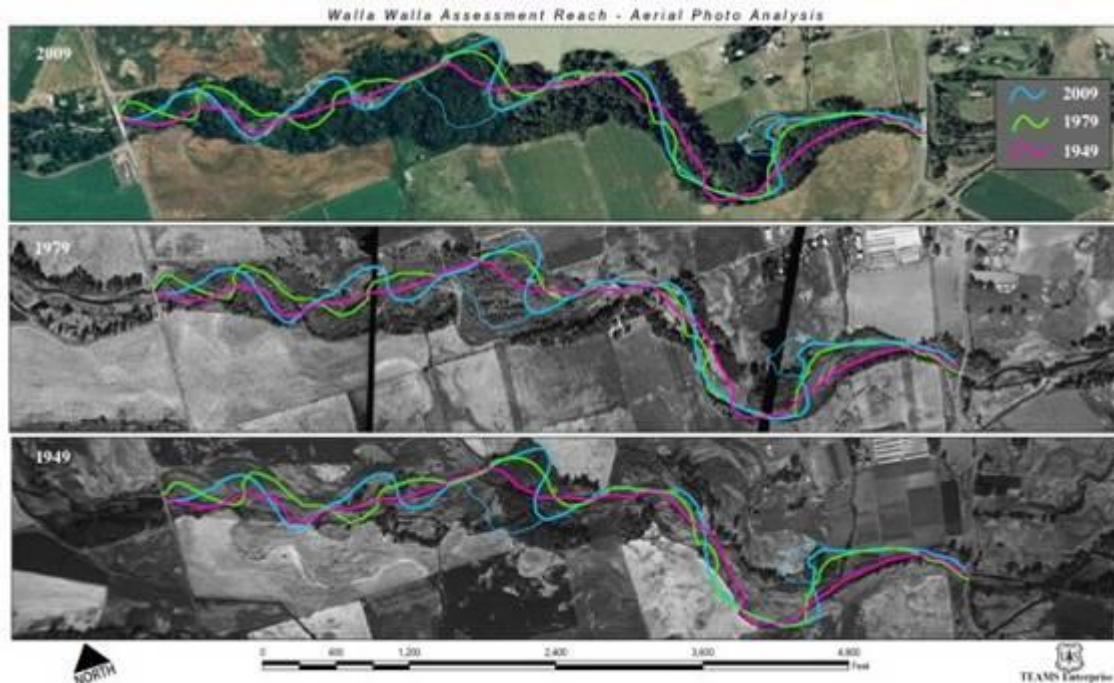
Figure 38. Location of the stream channel thalweg in 1949, 1979, and 2009 for the Walla Walla River assessment reach, Walla Walla River, Walla Walla County, Washington

A significant change to the channel pattern has occurred between 1949, 1979, 1996, and 2009 (figure 38). An increase in riparian vegetation and channel roughness has also occurred over this time period. For ease of analysis, this section compares aerial photos from 1949, 1979, and 2009 LiDAR intensity image.

A measure of the amount that a river meanders within its valley is termed sinuosity and is calculated by dividing total stream length by valley length or channel slope to valley slope. Sinuosity for the Walla Walla River is currently measured to be 1.4. It was estimated to be 1.2 in 1949 and 1.3 in 1979. In a functioning alluvial river system, higher sinuosity generally indicates that a stream channel has more access to move laterally across the valley, and also there is likely to be more side channel and groundwater channel habitat that typically form in abandoned meanders. This migration indicates that the stream channel has access to a floodplain during higher flows. This is important for reducing velocities during floods, capturing sediment, providing spawning gravels for fish, building stable stream banks, and providing a wide range of tree and plant age classes within the riparian zone. From the past photos, it appears that the stream channel conditions are improving since 1949.

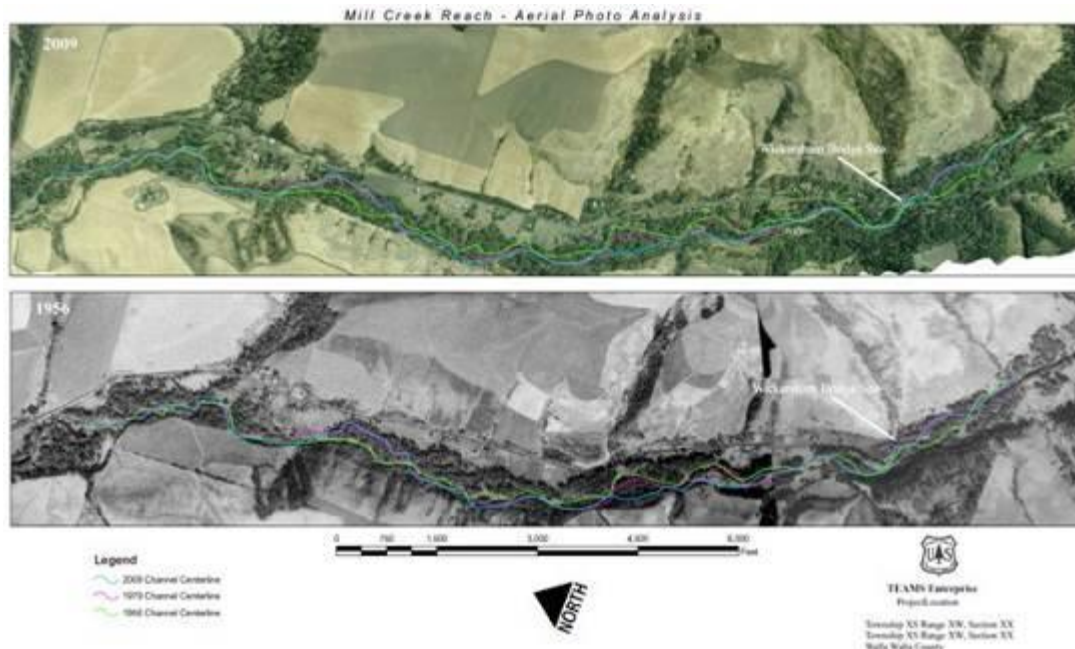
Figure 39. Location of the stream channel thalweg in 1956, 1979, and 2009 for the Mill Creek assessment reach, Mill Creek, Walla Walla County, Washington

Sinuosity in the Mill Creek assessment reach is currently 1.1 due to past channel straightening. In the oldest photo available (1956), the sinuosity is 1.1 as well (figure 39). It is likely that sinuosity in the reach was higher before development of the valley began. There are areas of the

assessment reach where the stream channel has shown signs of migration. The photos indicate a channel managed to remain confined along the eastern side of the valley. This has caused the channel gradient to be steeper than what would be expected historically. Vegetation in the valley has not changed significantly, with the exception of the forest stands becoming thicker and more decadent due to ongoing fire suppression.

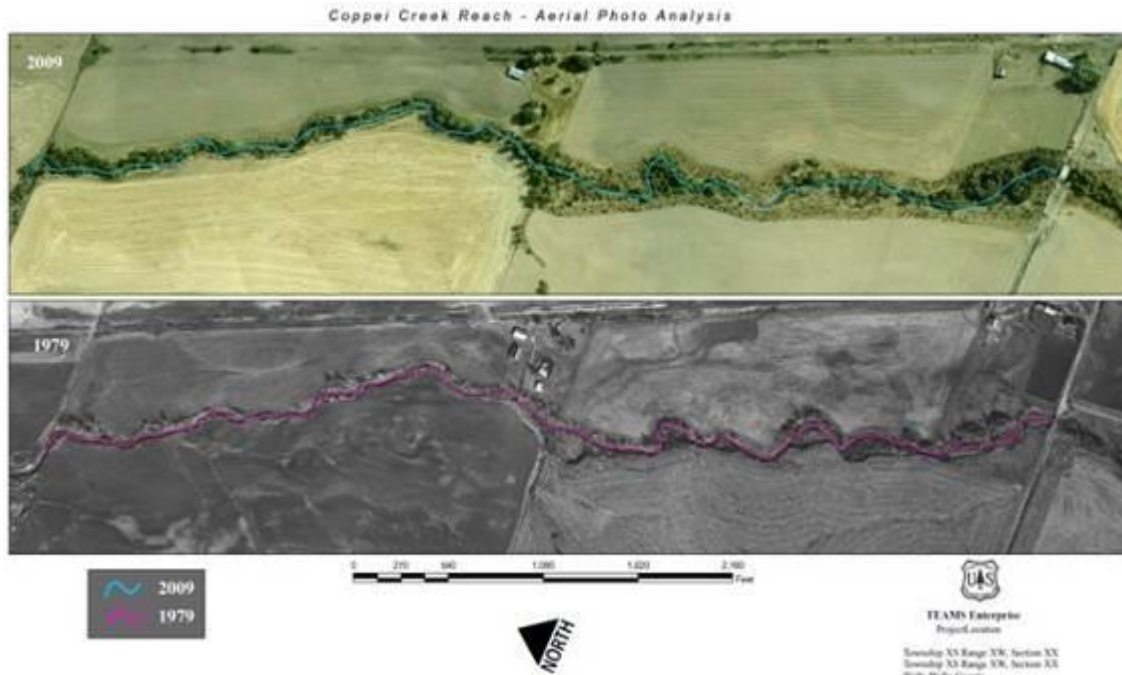
Figure 40. Location of the stream channel thalweg in 1979 and 2009 for the Coppei Creek assessment reach, Coppei Creek, Walla Walla County, Washington

The oldest photos available for the Coppei Creek assessment reach are from 1979. The photos indicate that the stream was channelized prior to these photos being taken. It is unclear when channel manipulation occurred. Sinuosity in the Coppei Creek reach is currently 1.0. It appears from the 1979 photos that the sinuosity was also 1.0 at that time (figure 40). The riparian width in 1979 constituted a small band of trees that lined the stream; this is generally still the case. However, the 2009 photo show the implementation of the CREP work completed through the FSA in 1999.

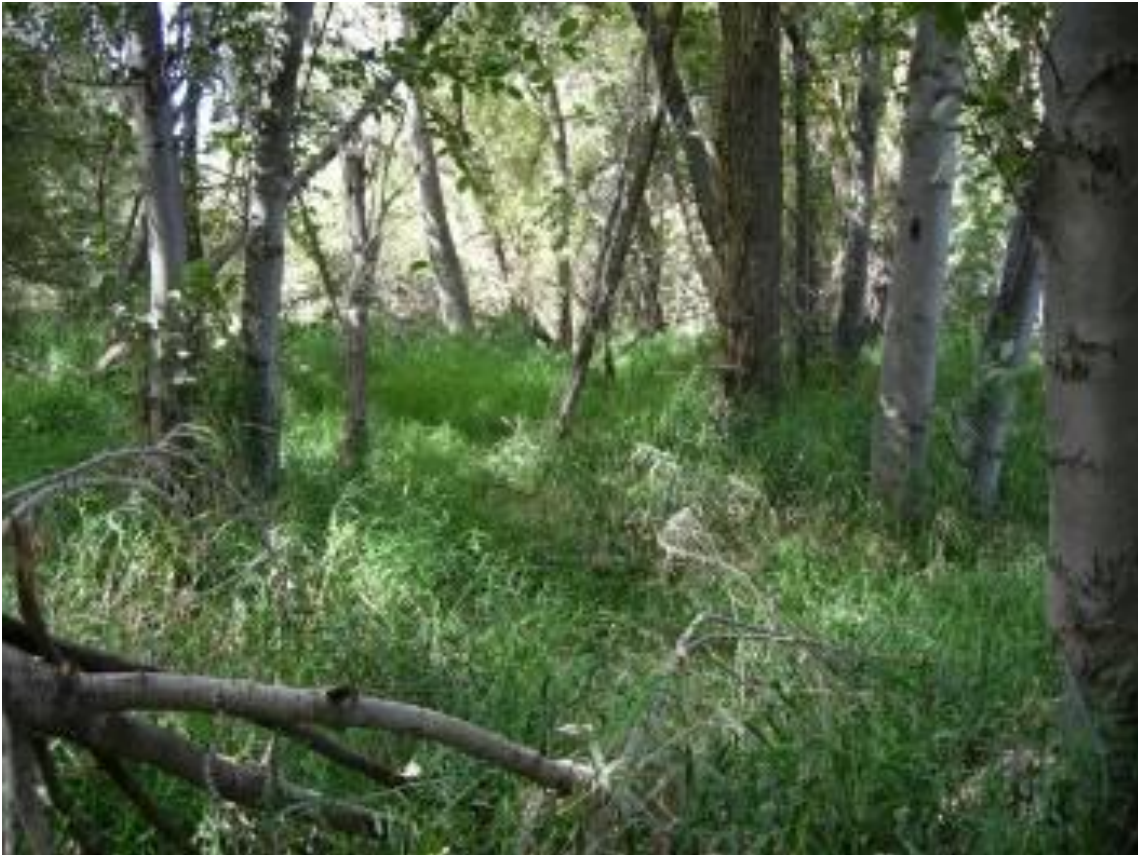
Figure 49. Dense riparian areas along the Walla Walla River assessment reach, Walla Walla River, Walla Walla, Washington

Vegetation in the assessment reach is dominated by medium-sized to mature black cottonwood-white alder stands with a subcanopy of both species and a few patches of regeneration. Other scattered and infrequent trees encountered in surveys include peachleaf willow, black locust, and Siberian elm. Older cottonwoods are typically 12 to 24 inches dbh (diameter at breast height), 50 to 70 feet tall, and occasionally have side sprouts. Cottonwood regeneration was observed in two of the four plots; young cottonwoods range between 0.5 and 10 feet tall. They are typically

scattered, but occasionally numerous on gravel bars. In many cases the cottonwood regeneration did not look healthy but was surviving. Younger alder typically occur in patches; they often make up the subcanopy layer and are between 6 and 10 inches in diameter and 30 to 40 feet tall. Cottonwood stands have increased 1.5 times in extent on the floodplain since the earliest

The understory is dominated by reed canarygrass, a common invasive in this area. Shrubs are rare in this reach, but there was some cover of snowberry and nonnative blackberry in surveyed plots. Except on the bars, there is little bare ground. Downed wood accounts for 5 to 20 percent of the ground cover.

Disturbances along this reach are recent and historic, natural, and man-made. Invasive plants are common in disturbed areas such as along road edges. There is a particularly dense patch of weeds (Scotch thistle, teasel, yellow spike, cheatgrass, poison hemlock) between the riparian zone and the adjacent field on the north side of the river near the middle of the reach.

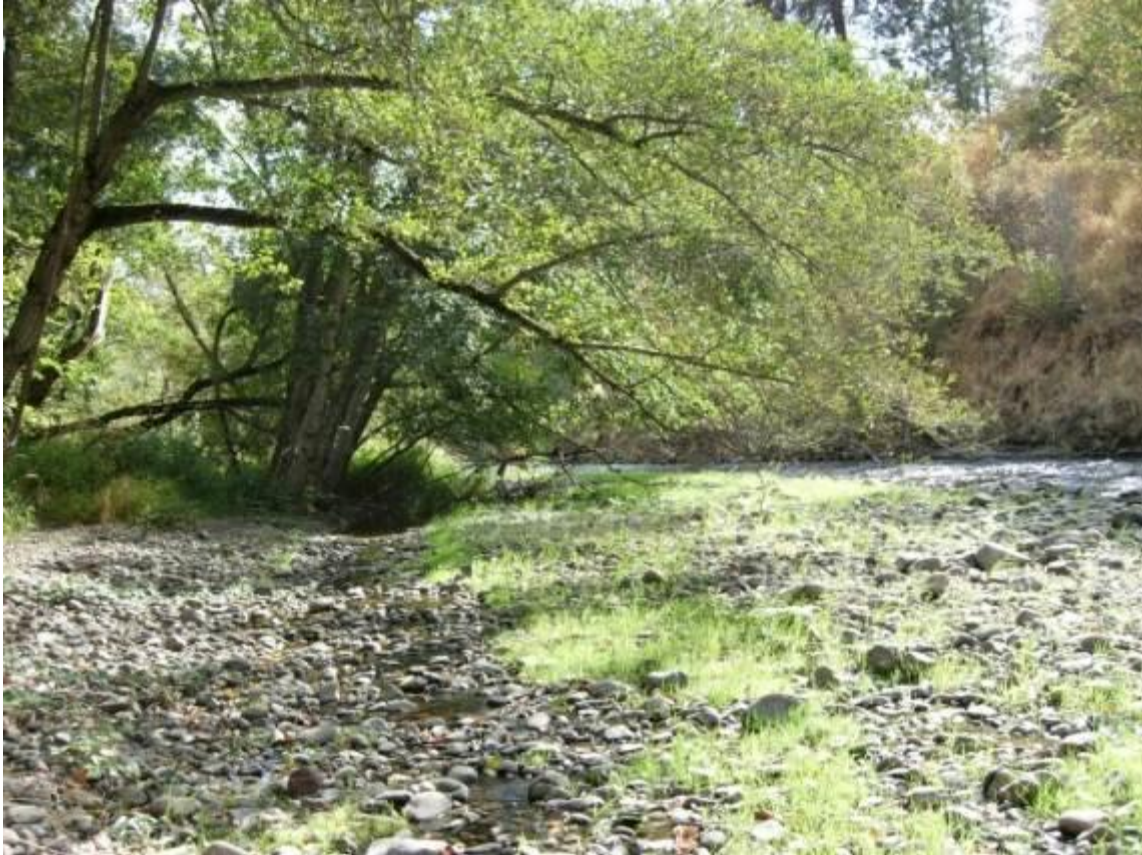
Figure 51. Mill Creek has a more open riparian area along the channel

Vegetation along Mill Creek is dominated by medium-sized to mature black cottonwood-white alder stands with a subcanopy of both species and patches of smaller trees in the subcanopy. The only other trees encountered in surveys were black locust and a few small ponderosa pines. Cottonwoods in the reach are typically 12 to 24 inches dbh, but larger trees up to 36 inches dbh were observed outside survey plots. Alder, cottonwood, and black locust (30 to 45 feet tall) make up the subcanopy. Tree regeneration is very limited along this reach. The younger alders are approximately 3 inches dbh and 30 feet tall. Three trees were found in the youngest age class: two ponderosa pines approximately 6 feet tall and one black locust approximately 10 feet tall. Few young cottonwoods were present in surveyed stands, with the smallest being about 25 feet tall.

The understory is composed mostly of herbaceous nonnative invasive species. There is essentially no bare ground. Downed wood was observed to be 14 percent of the ground cover. The dominant herbaceous species is reed canarygrass.

Residential development and agricultural fields occur on both sides of the creek, apparently limiting the width of the riparian vegetation. There are several areas of CREP revegetation plantings in and at the back of the riparian zone dominated by ponderosa pine and black locust.

Invasive plants are common and occurred in all plots. Among the most common are several naturalized species—reed canarygrass, blackberries, and sweetbriar rose. Houndstongue is also common, as are pasture grasses such as timothy and orchard grass. Other species (mullein, bull thistle, and poison hemlock) are less common, but could easily spread in the future. Japanese knotweed occurs in the stream and poses a serious long-term threat to the natural vegetation of this reach.
