May 2010

Walla Walla River, Mill Creek, and Coppei Creek Geomorphic Assessment

Walla Walla County Conservation District and
U.S. Forest Service, TEAMS Enterprise Unit

Compiled: April, 2010; Revised: May 2010

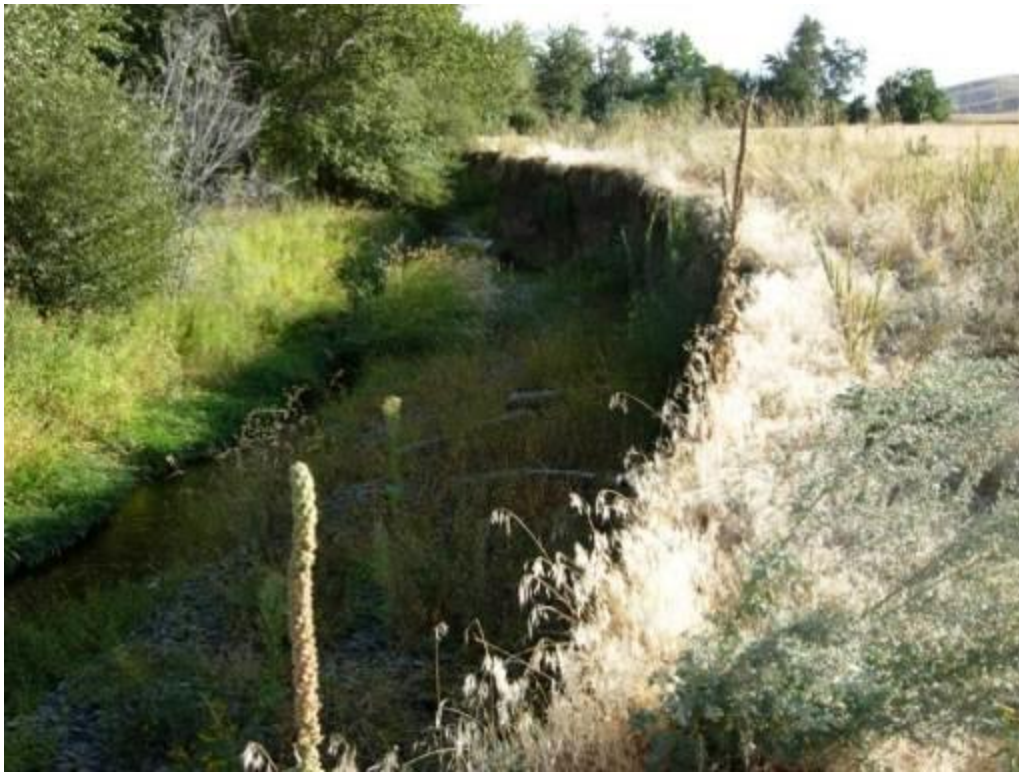
Figure 52. Coppei Creek riparian area

Disturbances along this reach include an abundance of weeds, a road through the riparian vegetation to the creek, an old car on the streambank near the McCown Bridge, CREP revegetation plantings, and agricultural fields on both sides of the stream.

Invasive species were less common in survey plots on the Coppei Creek assessment reach than on the other reaches. However, reed canarygrass is abundant and a wide strip of weeds (approximately 10-foot wide) divides much of the riparian vegetation from the fields on either side of the stream.

Note: Channel down-cutting with dryer terraces above the stream.

Coppei Creek Reach. This reach is considered to be in a highly degraded state. Percent pool length and pool depths are low (table 5) and fine sediment from eroding banks and upstream sources cover streambed sediments that clogs interstitial spaces between streambed gravels reducing cover and food for juvenile salmonids. Artificial rip-rap placed along banks in some areas to prevent erosion offers little fish habitat (figure 54). The high banks and lack of floodplain connectivity increase shear stresses during high stream flows limiting off channel habitat and flood refuge for fish. Shading over the channel is poor with an average value of 50 percent. Large woody debris values are also low at 10 pieces per mile. Habitat quality and productivity for fish are limited in this reach by the lack of deep pools or other slow water habitat, the lack of channel complexity, limited large wood material, and poor riparian health.

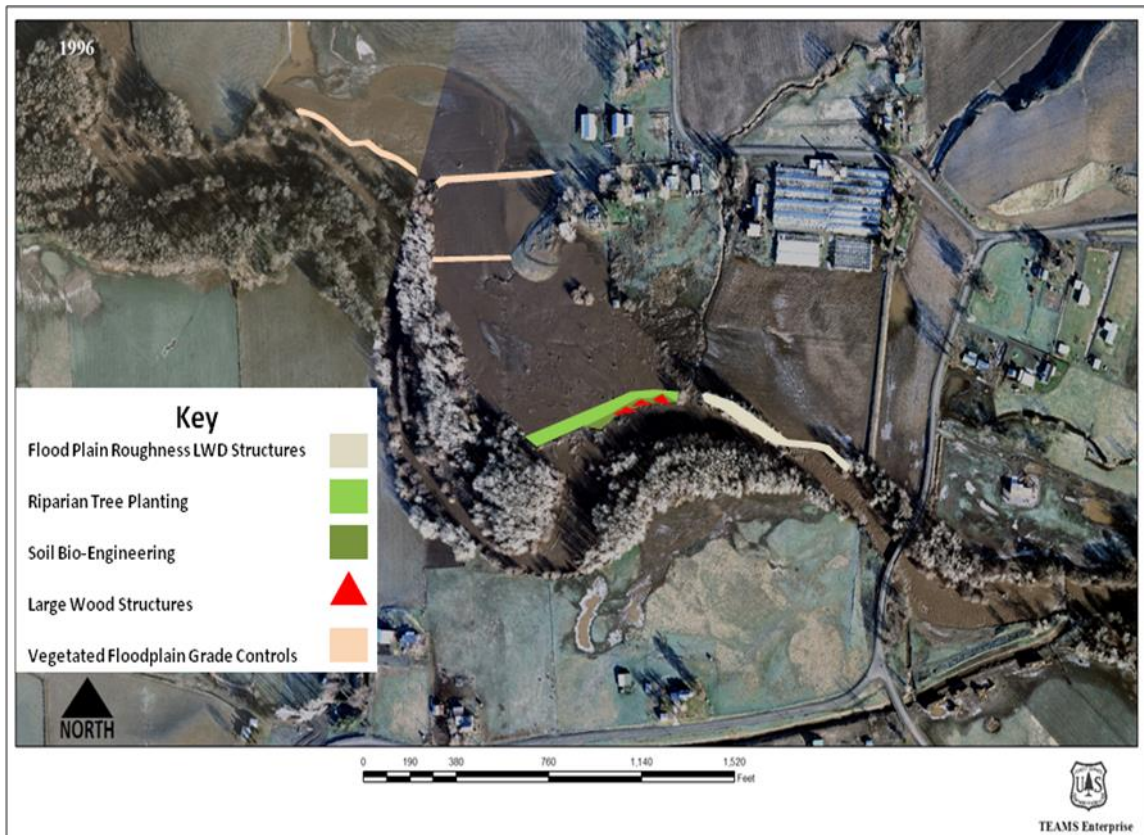
Figure 56. Walla Walla River Johnson property restoration plan and design

Garrison Creek enters the Walla Walla River just downstream of the Frog Hollow Road Bridge contributing flow and substantial sediment. The fanning effect of the sediment deposition at the confluence with the Walla Walla River creates channel braiding and lateral migration. The right bank of the fan area below the tributary is devoid of riparian and floodplain vegetation and is actively eroding. A combination of large wood structures, soil bio-engineering and riparian CREP buffer strip plantings are proposed to rehabilitate the site.

Vegetated, earthen floodplain grade controls are proposed for this area to allow flood waters to spread across the flood plain naturally while reducing erosive water velocities and encouraging sediment deposition within the historic floodplain. The vegetated earthen structures would be constructed along fence lines or along strategic areas to maximize the effectiveness of the structures (see figure 56). This will reduce the overall gradient across the pasture, decreasing the erosive energy of larger floods.

Estimated cost for implementation of the Johnson property project is \$227,000.

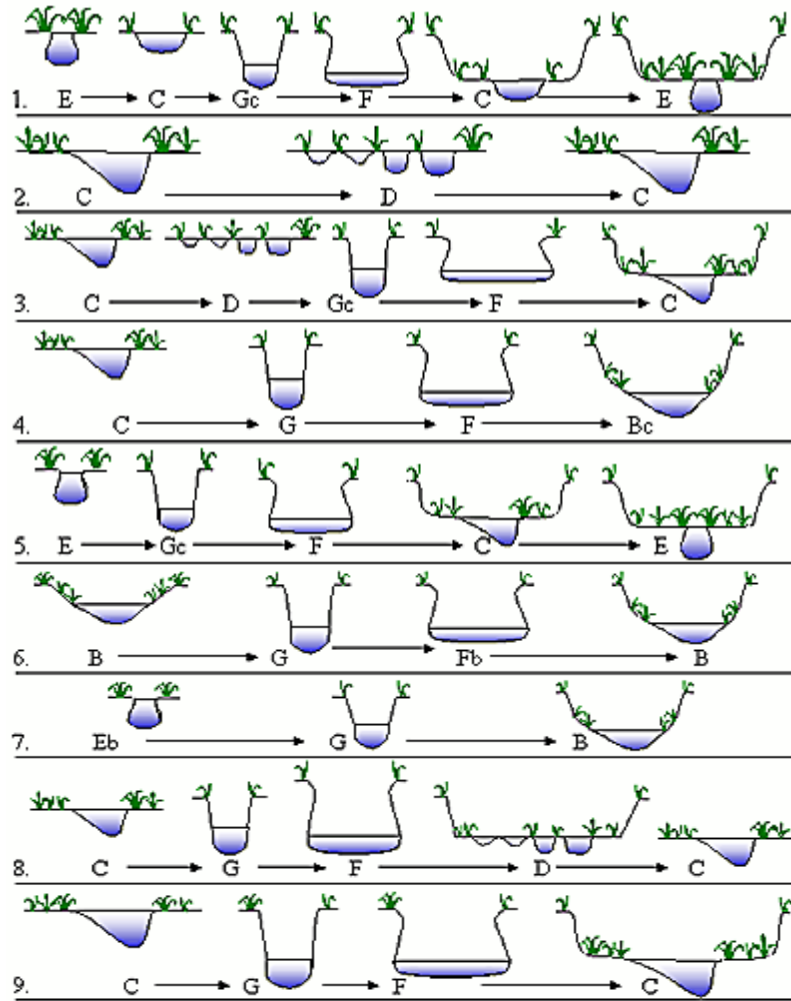
Figure 58. Possible channel evolution scenarios for Coppei Creek channel in the incised portion of the assessment reach using Rosgen (1999) classification

Note: For deeply incised stream like Coppei, channels must widen to create a new floodplain within the incised channel.

The rehabilitation goals for the Coppei Creek assessment reach are to allow the channel to connect to historic floodplains while still allowing for human uses, restore stream channel and bank stability and restore and maximize riparian areas, which will help to moderate the effects of large floods, and to recover the natural range of aquatic and riparian habitat conditions to which native fish and wildlife are adapted. Most of the assessment reach is deeply incised or down-cut, which limits options for expansion of floodplains. The channel along the assessment reach appears to be purposefully confined by push-up berms that were designed to expand agriculture in the valley. The berms or levees concentrated stream energy and initiated the channel down-cutting. Without extensive excavation, little can be done to recover the stream and expand the floodplain. The channel will erode streambanks and create more floodplain over time, but it will take many years for the stream to adjust. As a result, the channel and banks will chronically erode every year and continue to be a large source of fine sediment to downstream areas for many years as it expands the floodplain through lateral erosion. Beaver dams that have been established in recent years may help settle fine sediment and cause the channel to aggrade, but this will require many years of channel adjustment.

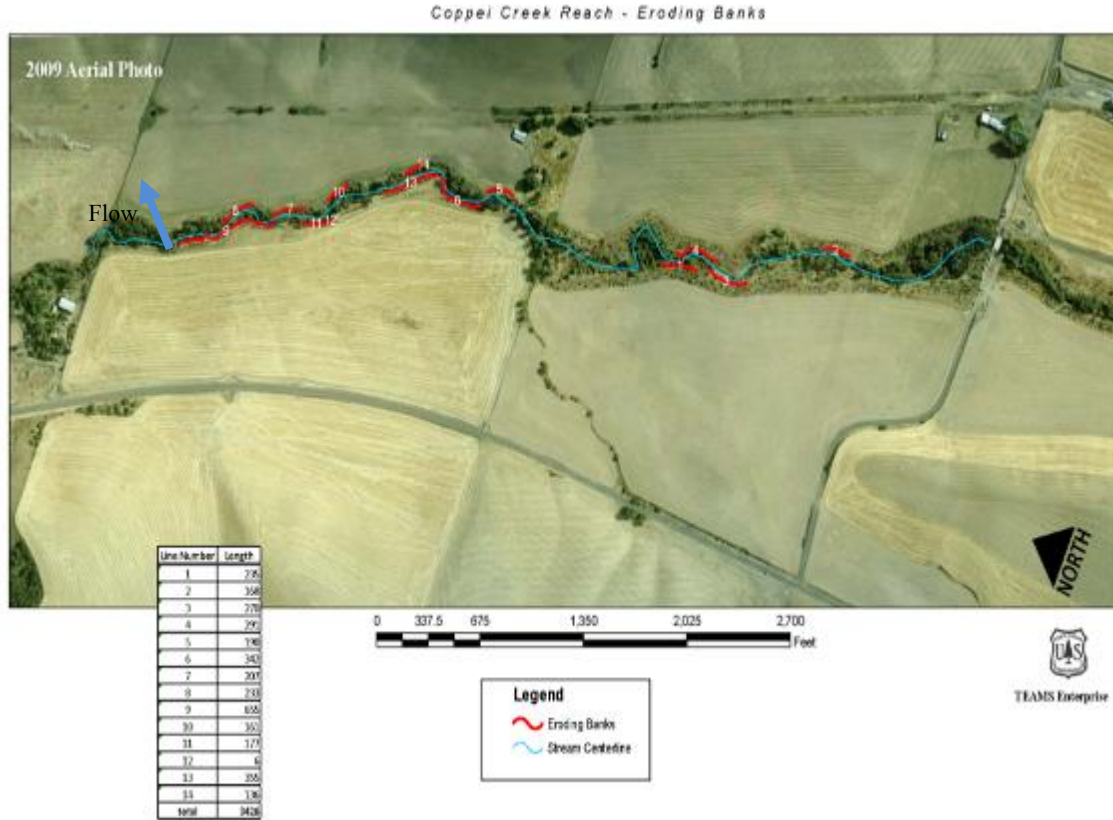
Figure 59. Coppei Creek restoration area

The lower half of the assessment reach is highly entrenched and actively eroding streambanks are contributing significant amounts of fine sediment to the downstream reaches. In addition, pool frequency and quality has been significantly impacted by stream entrenchment and fine sediment deposition. This project proposes to reduce erosion and improve aquatic habitat by excavating or pulling back streambanks on the outside of meander bends to reduce entrenchment, allowing peakflows to spread out over a greater area and reduce near bank shear stress. This project will also be designed to increase pool frequency and quality and hiding cover for fish.

- Implement bank stabilization along the assessment reach in combination with excavating banks to create more floodplain on the outside of existing meander bends in the incised channel. Along the reach where banks are actively eroding streambanks will be pulled back to provide a more flood prone width. Bank excavation will pull back the banks to a 3:1 slope with spoils spread out over the adjacent terrace. Excavated slopes and exposed soil will be mulched and revegetated with native grasses, shrubs and trees. Estimated cost for implementation of this project is \$220,000. Plant riparian tree species along the channel and created floodplain. Enlarge floodplain where needed in the upper end. Once floodplain is widened place trees with rootwads in the channel at existing pools to increase channel pool scour and cover for fish.
