Walla Walla County Conservation District Dozier Instream Fish Habitat

Restoration

Project Implementation Report

WA-SRFB Grant 07-1527R Touchet River Mile 42.5 Habitat Enhancement

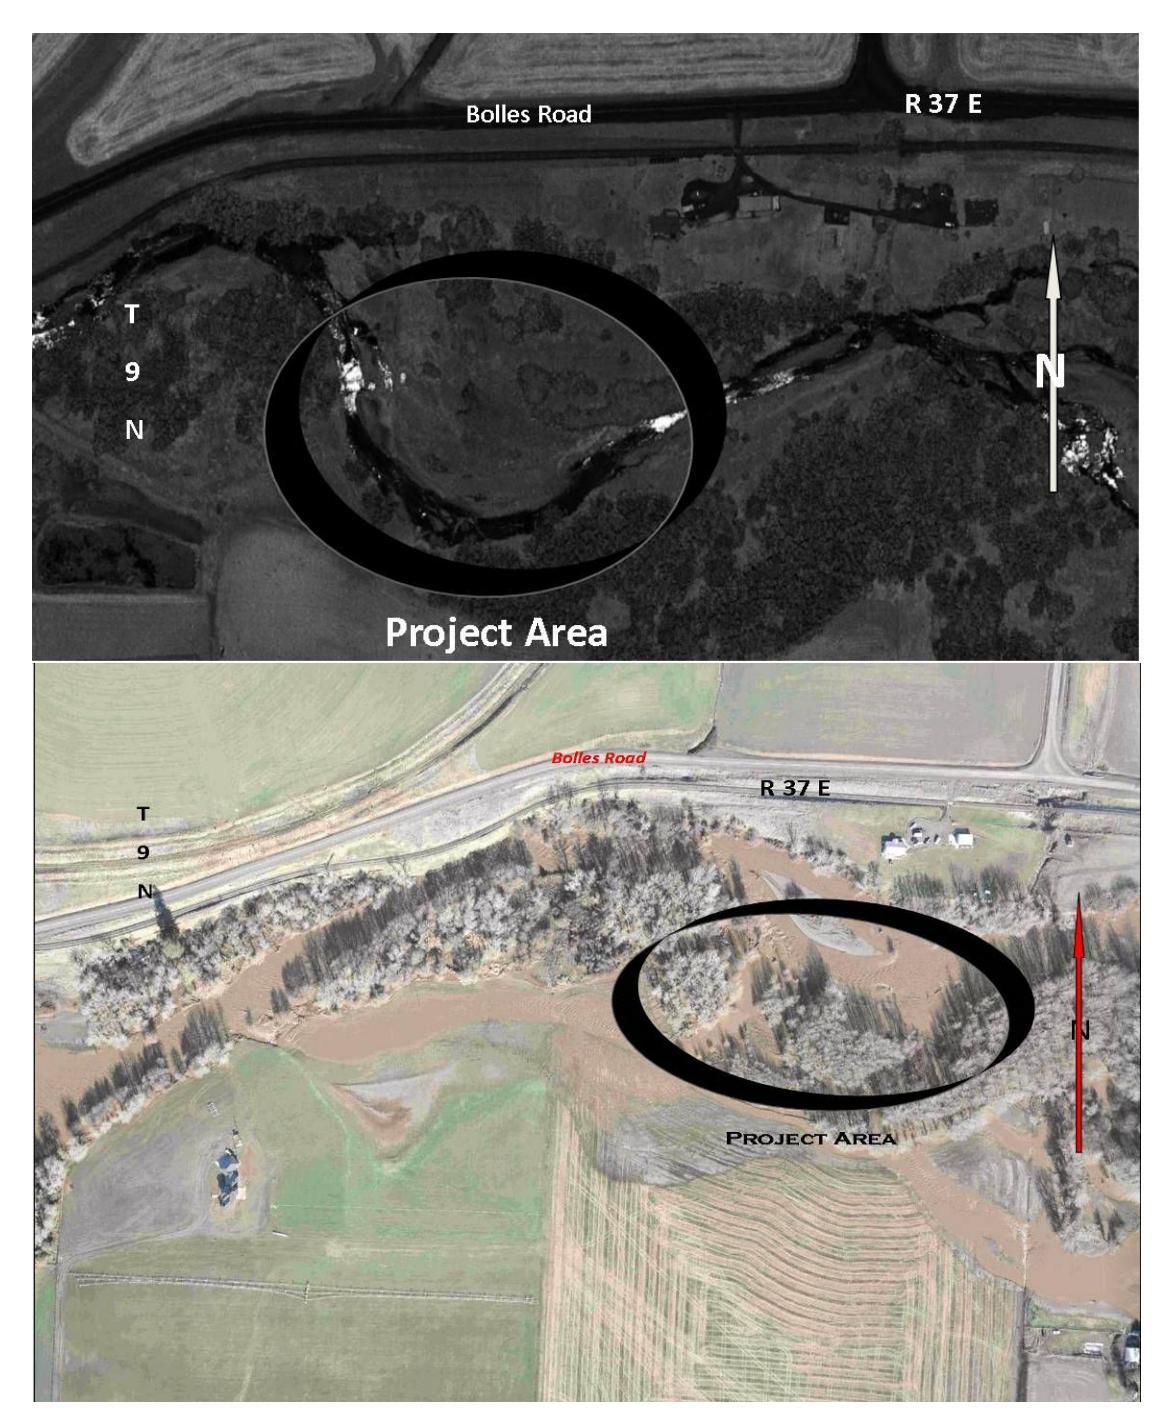
The Touchet River on the Dozier Farm prior to and during the 1996 flood event

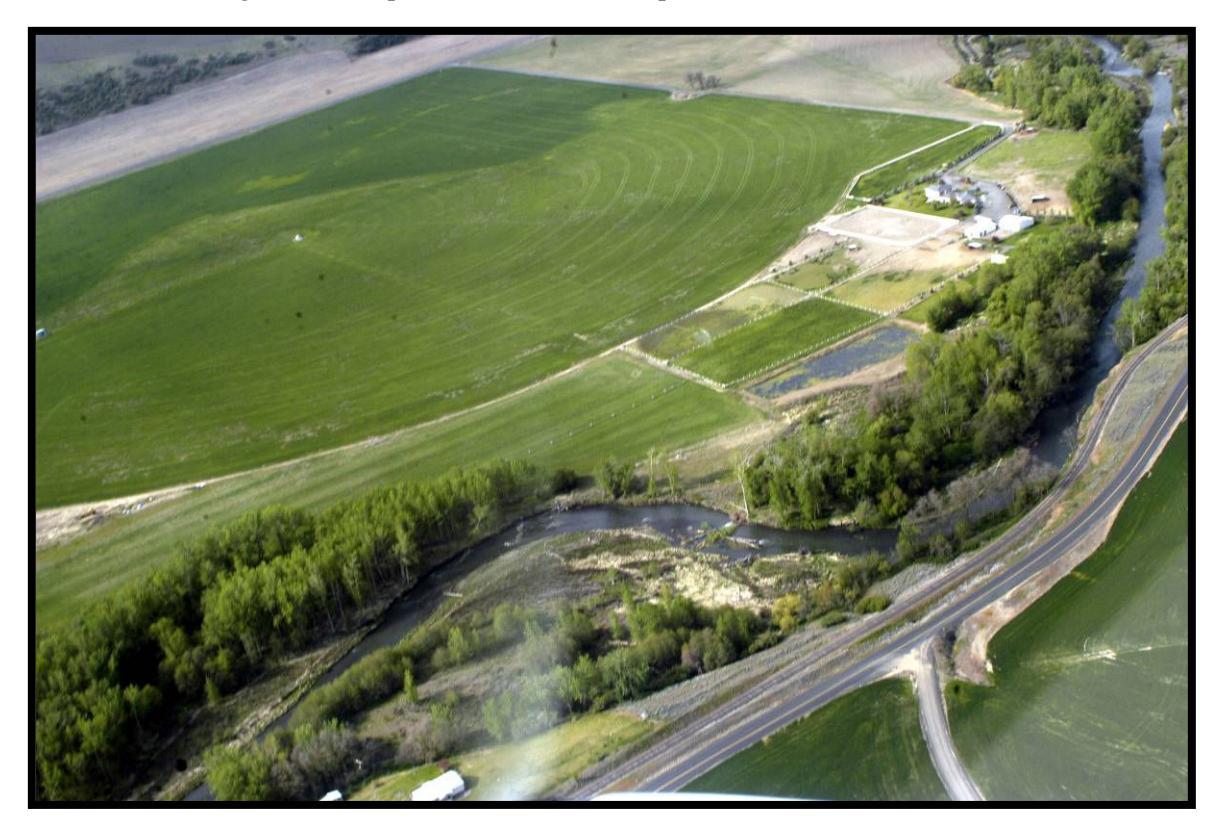
Start of an over-extended meander just east of the Dozier farm headquarters in 2008. Runoff events in the spring of 2009 and 2010 further extended the meander.

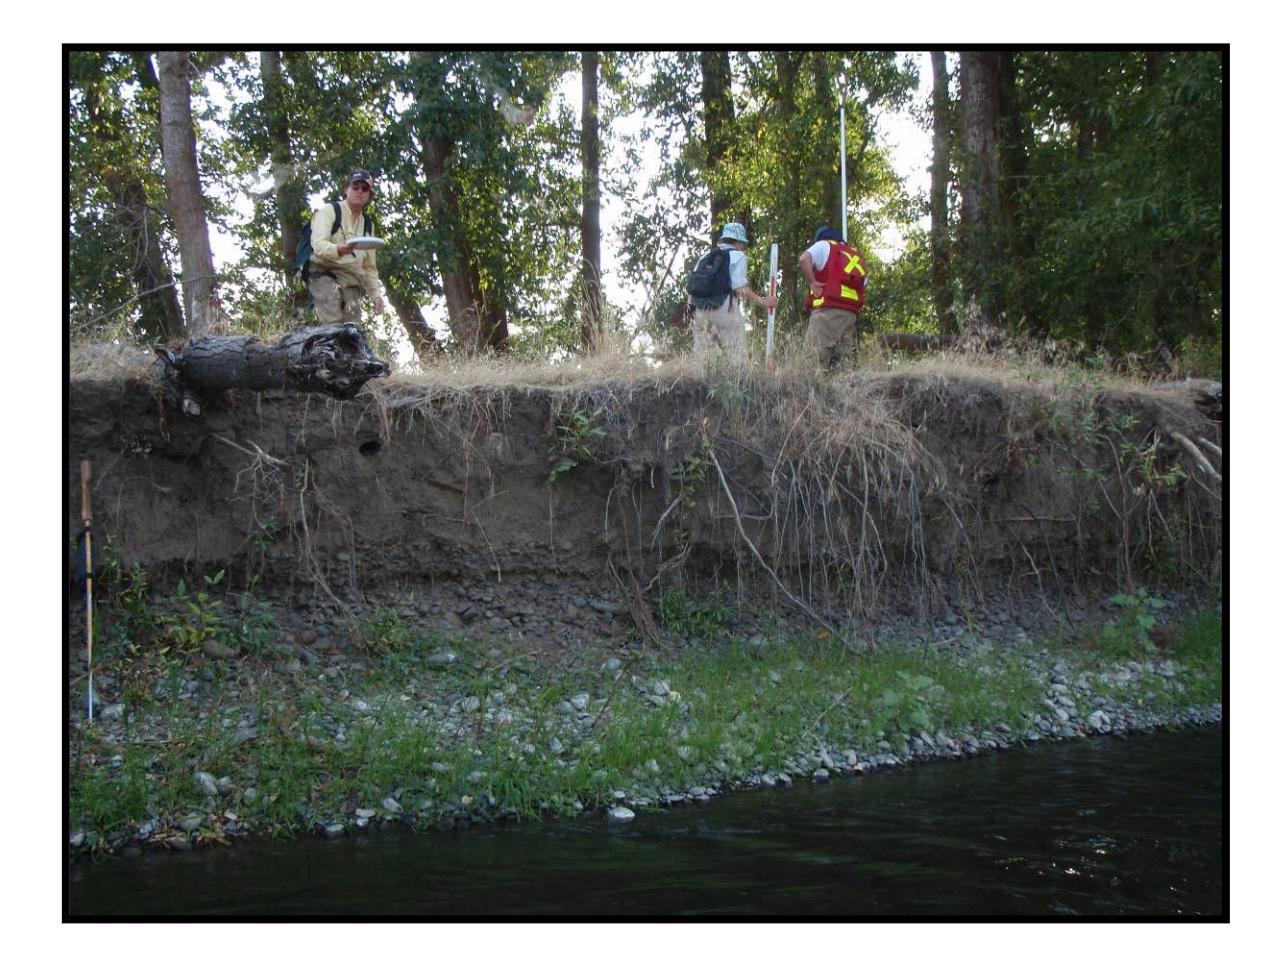
U.S. Forest Service TEAMS personnel conducting the fluvial geomorphic assessment. Note 3-4 feet of silt loam soils over unconsolidated gravel – a highly unstable condition.

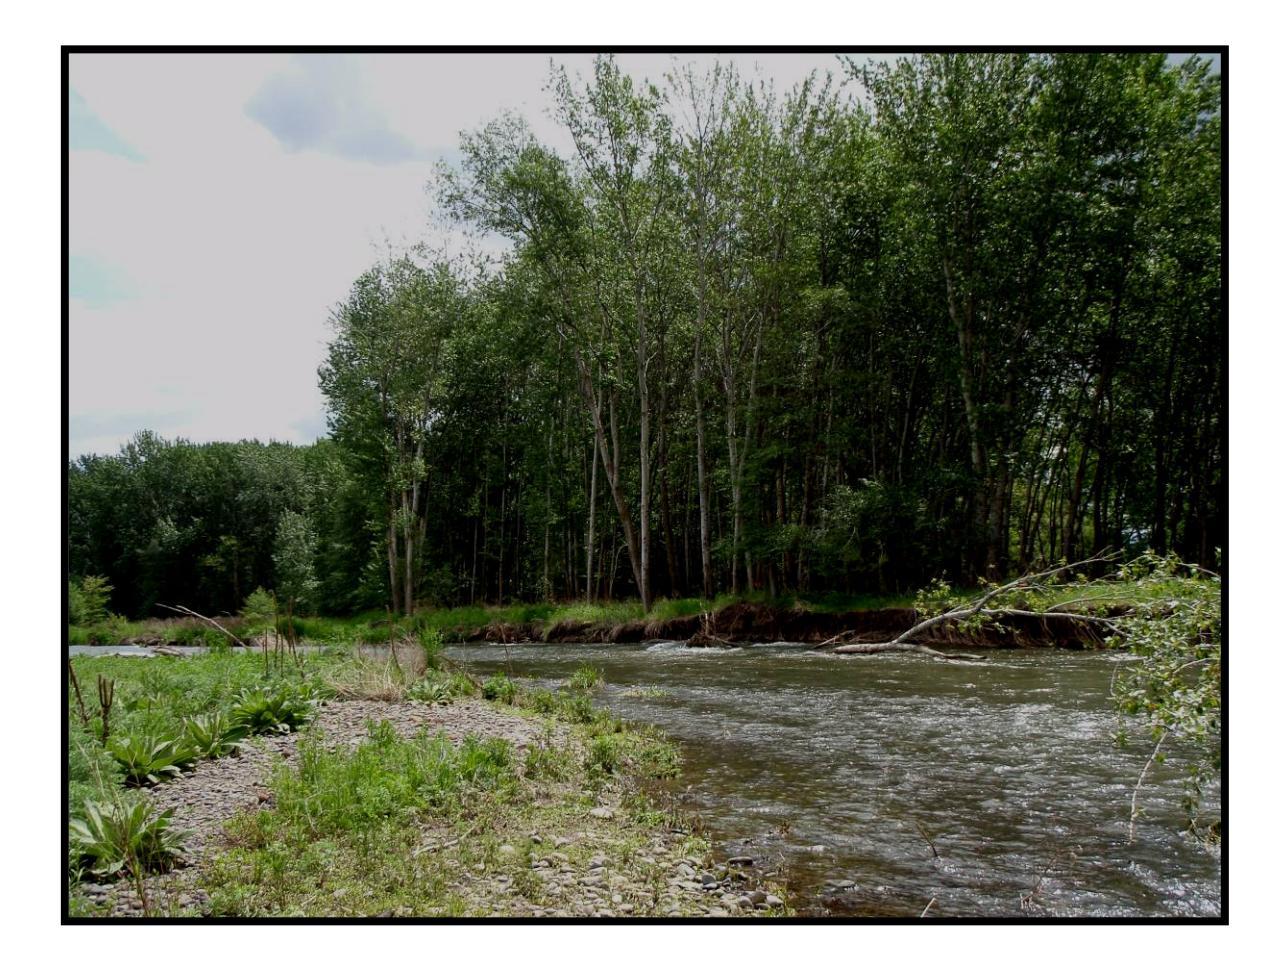
Same eroding bank as shown above in a highly unstable condition.

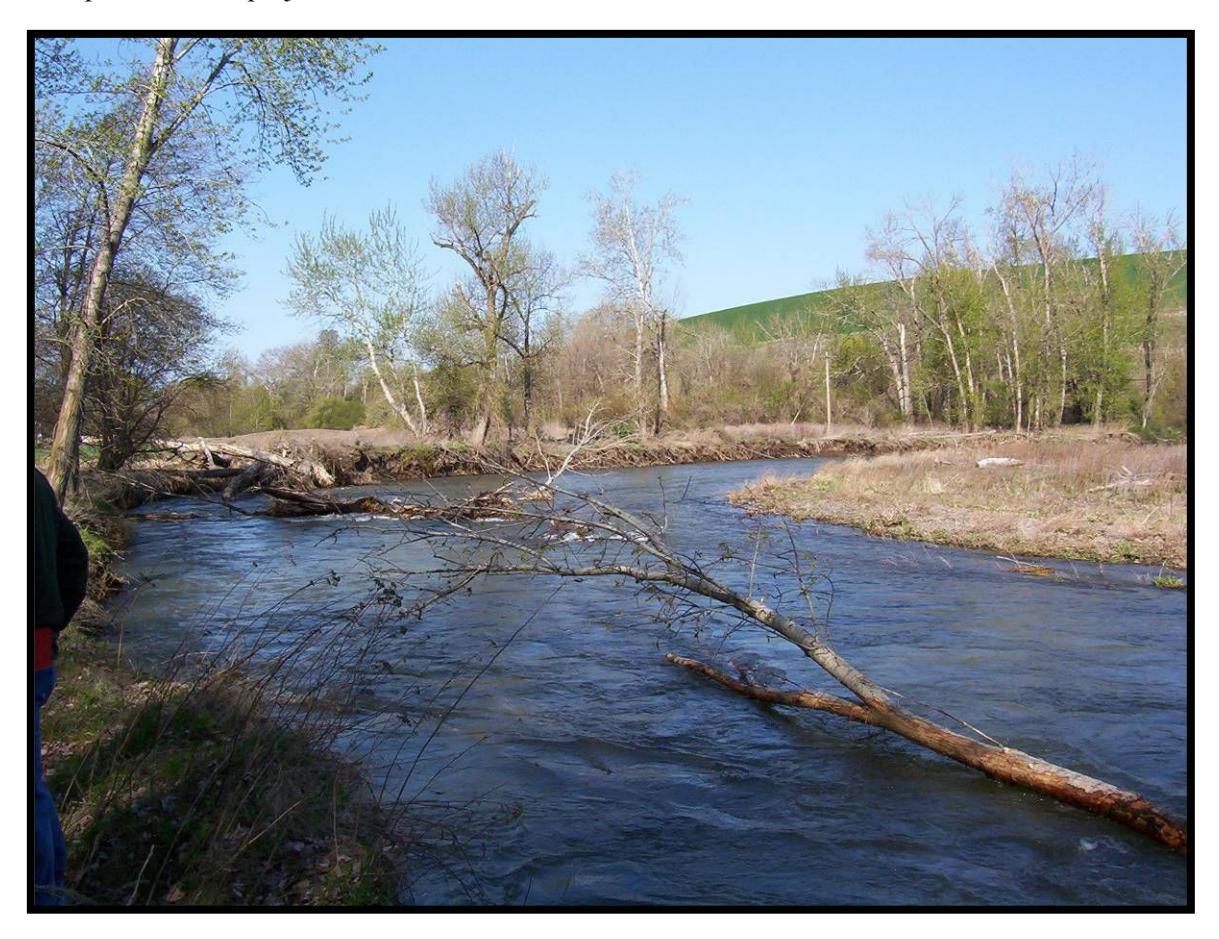
A westward view of the over-extended meander. The Dozier Farm headquarters lie downstream in line with the down tree in the foreground.

With the over-extended meander getting worse with each high water event, landowner Perry Dozier contacted Washington Department of Fish and Wildlife (WDFW) engineer Bruce Heiner for his recommendations for repairing the most problematic area. Dozier contracted with Barker Excavation to do the instream installation work which was started in the late summer work window of 2009. Natural Reclamation Service was selected to do the riparian restoration component of the project.

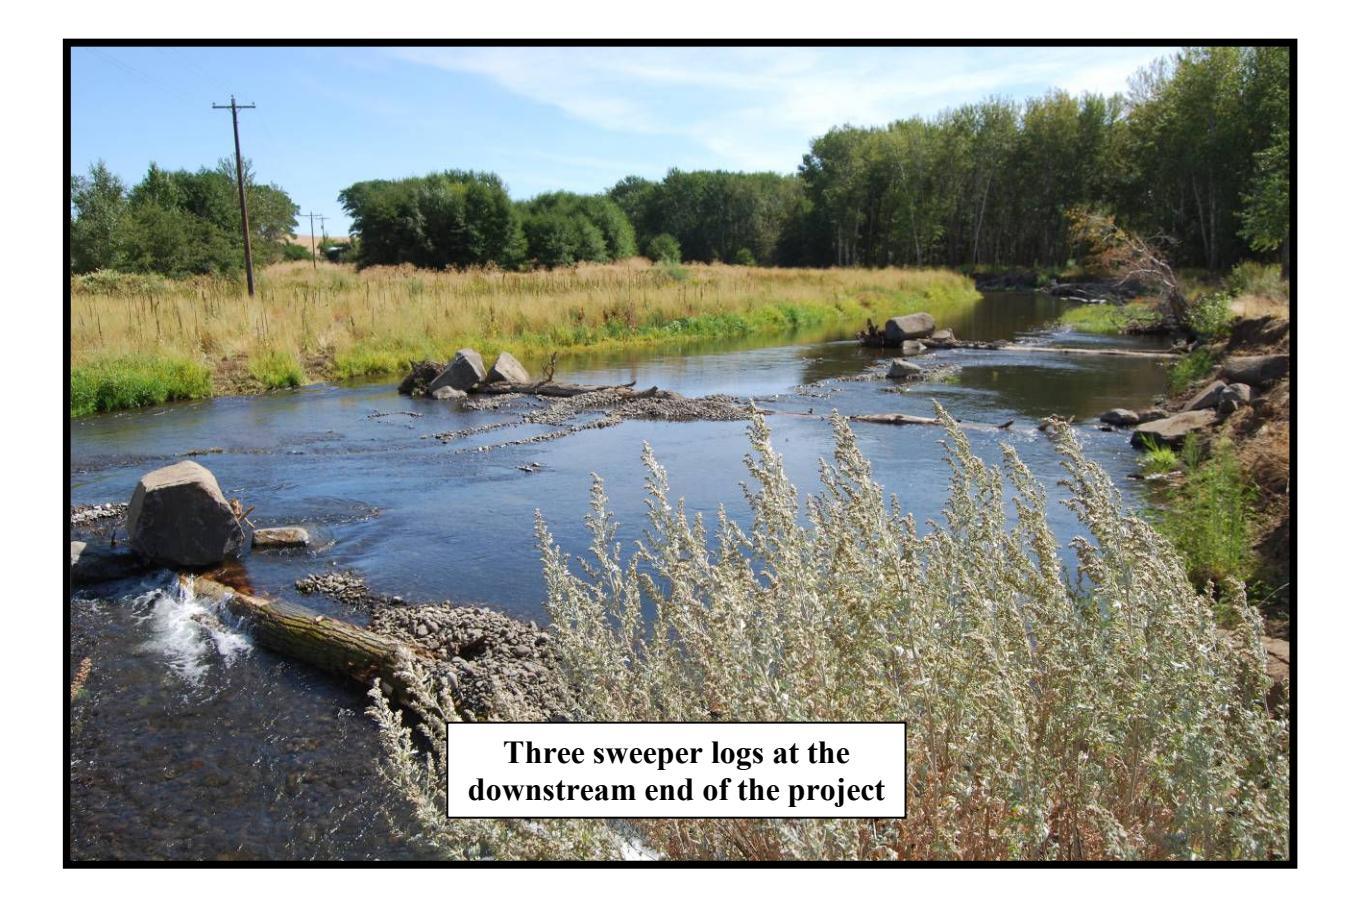
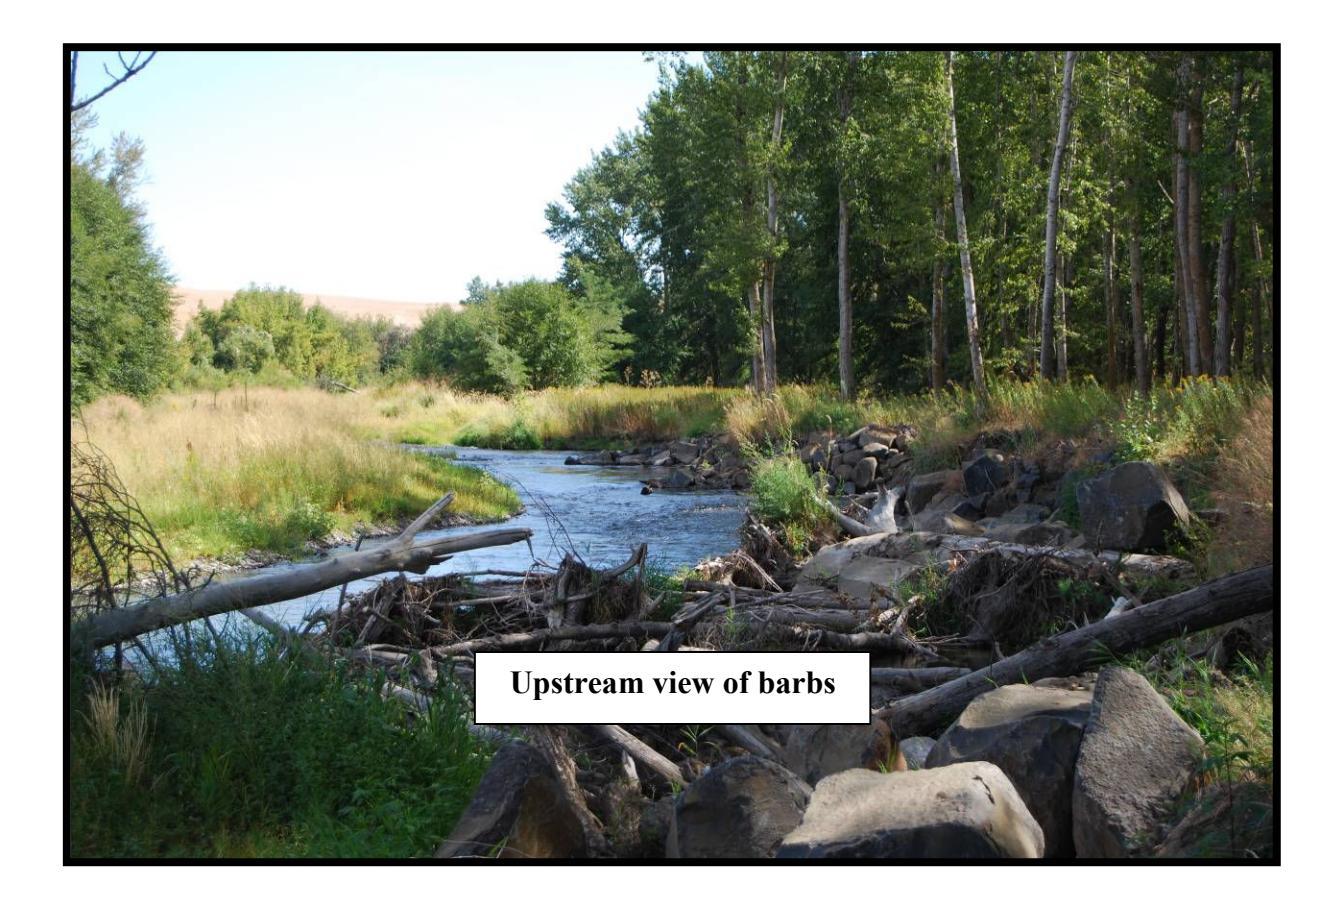
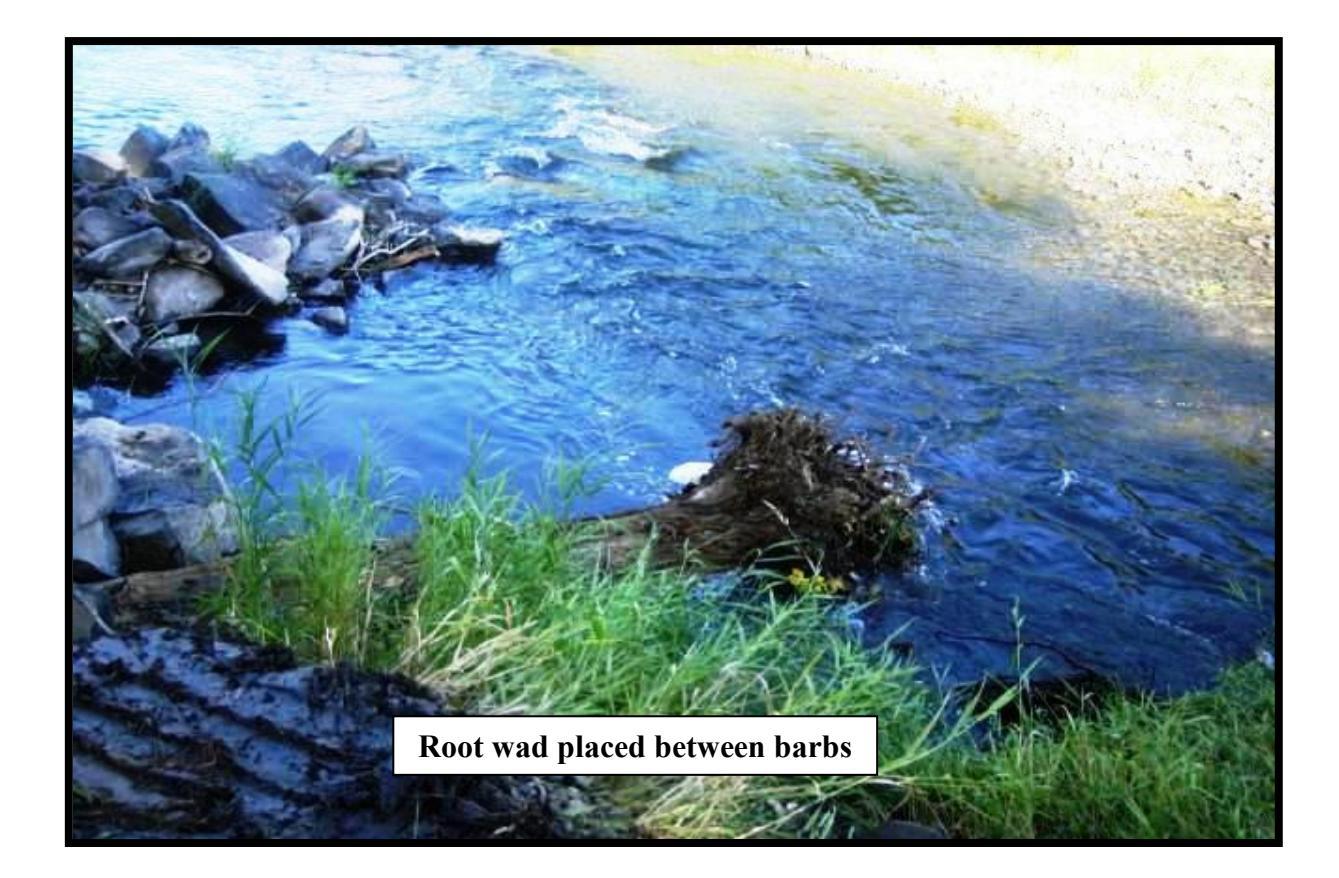
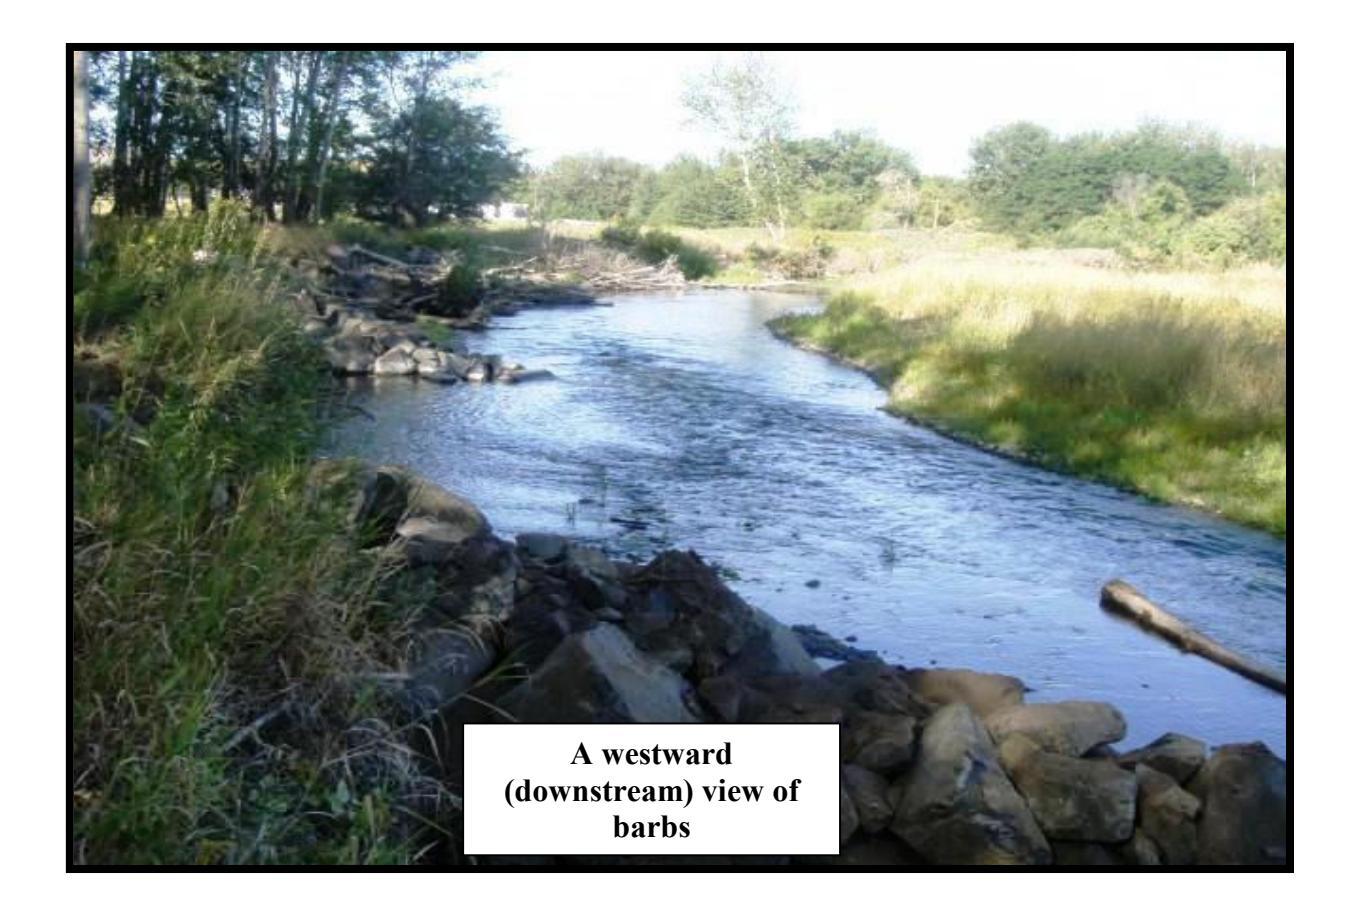
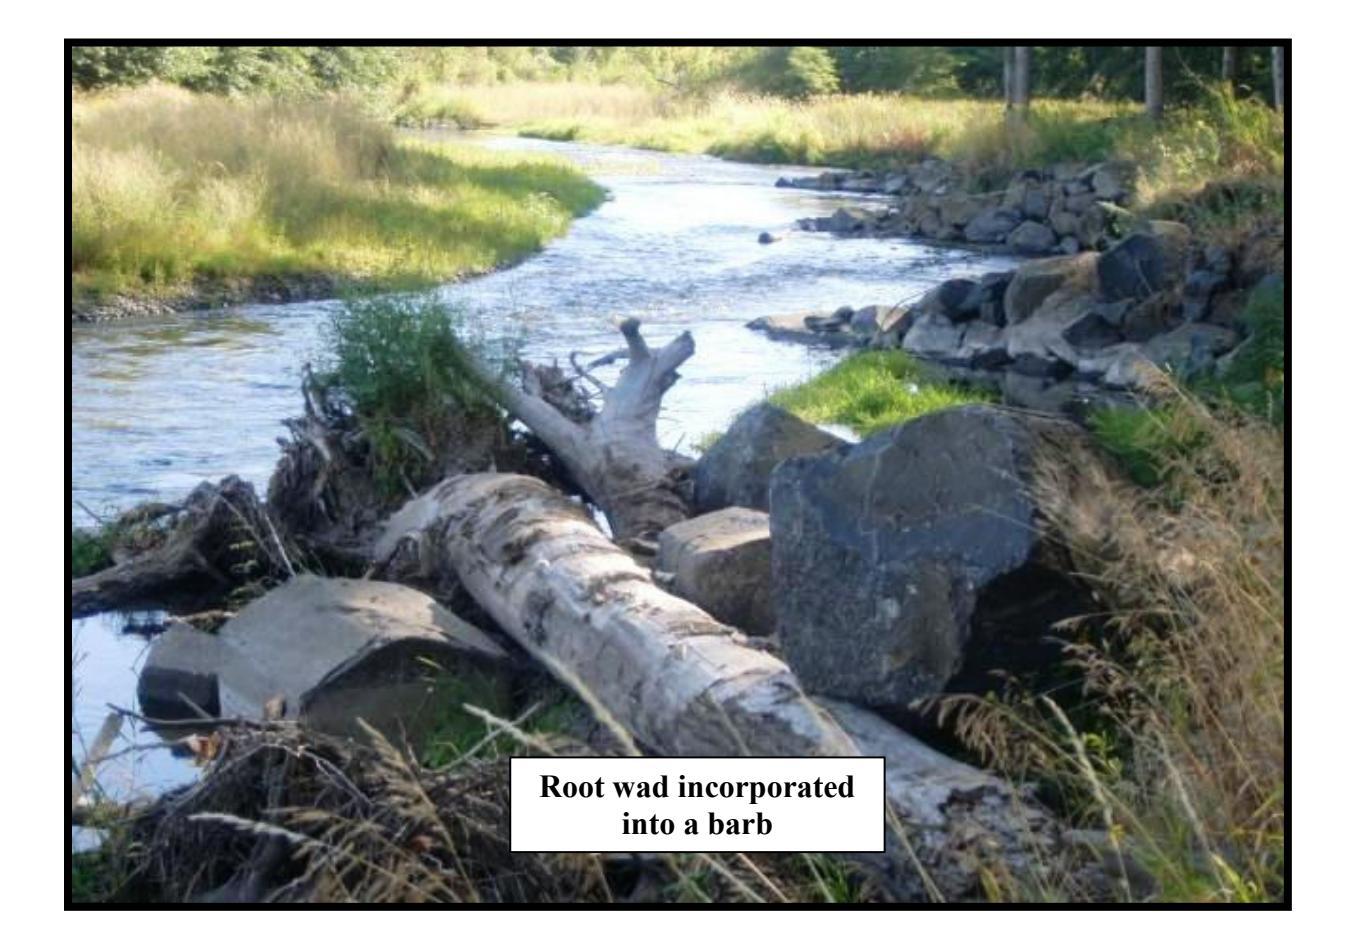
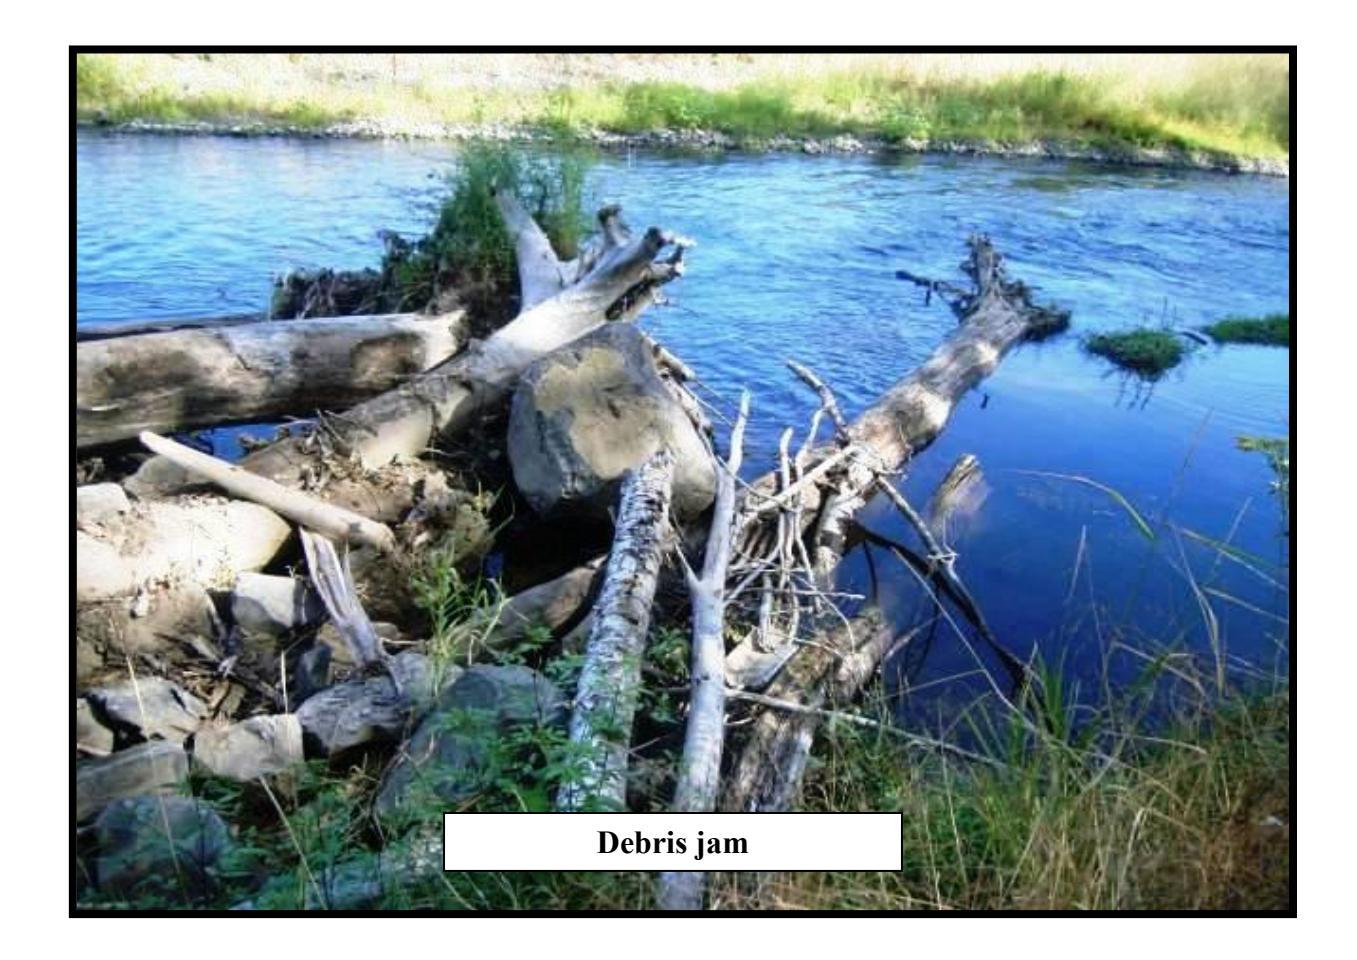
The total project costs were \$78,198.00. The following photographs show what was accomplished with benefits to both fish habitat and water quality.

- 5 rock barbs
- 5 root wads
- 3 sweeper logs
- 2 relief channel rough structures
- 1.2 acres of native grass seeding
- 2,100 feet of stream bank treated
- 3,260 native upland plants installed
- 2.9 acres of riparian zone enhanced
