Walla Walla County Conservation District

Titus Creek Screen Project

Titus Fish Passage and Screening

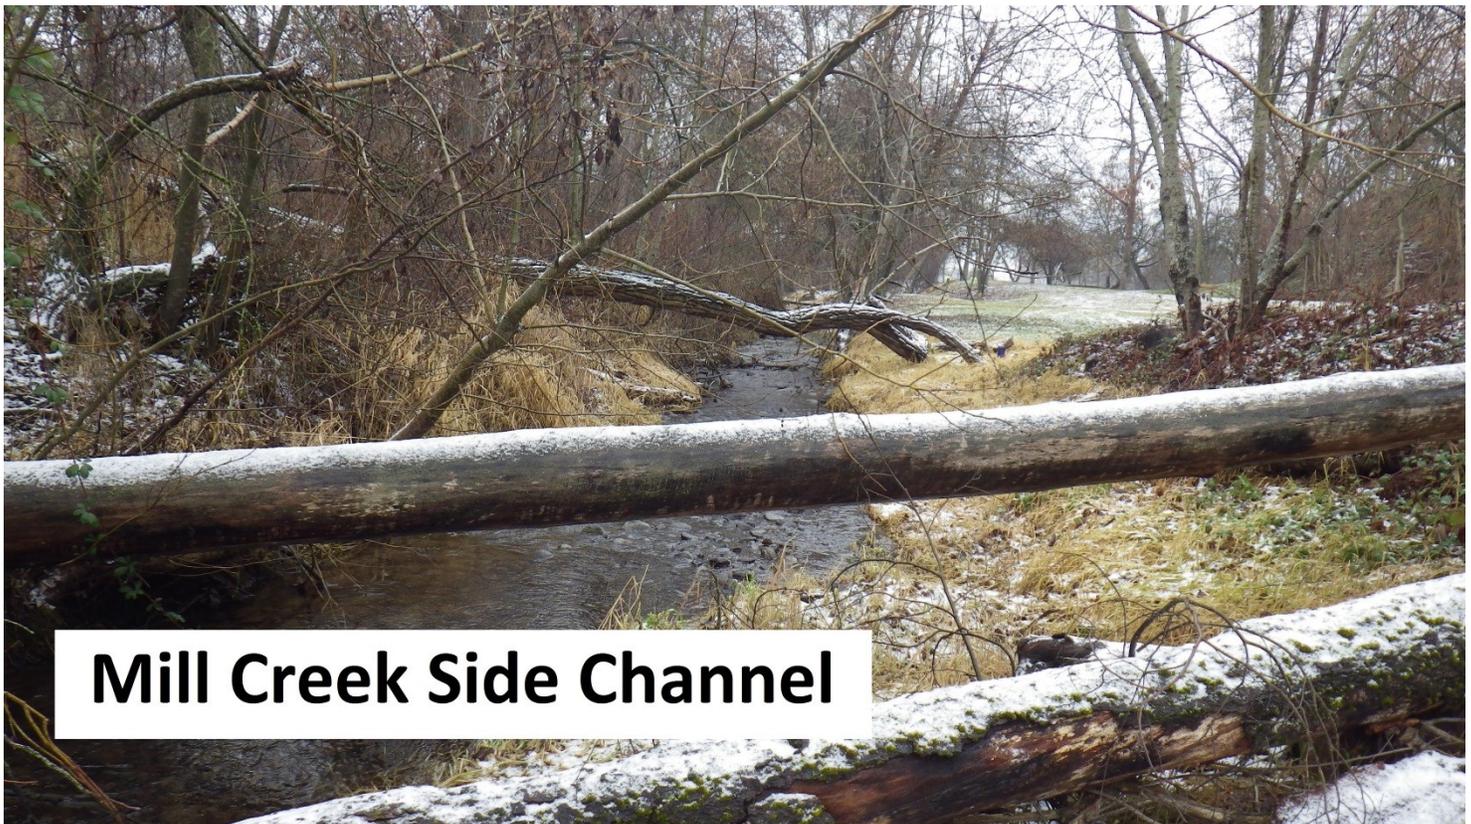
The Mill Creek side channel, on the other hand, provides excellent spawning and rearing habitat for steelhead. Below is a pre-project photo.

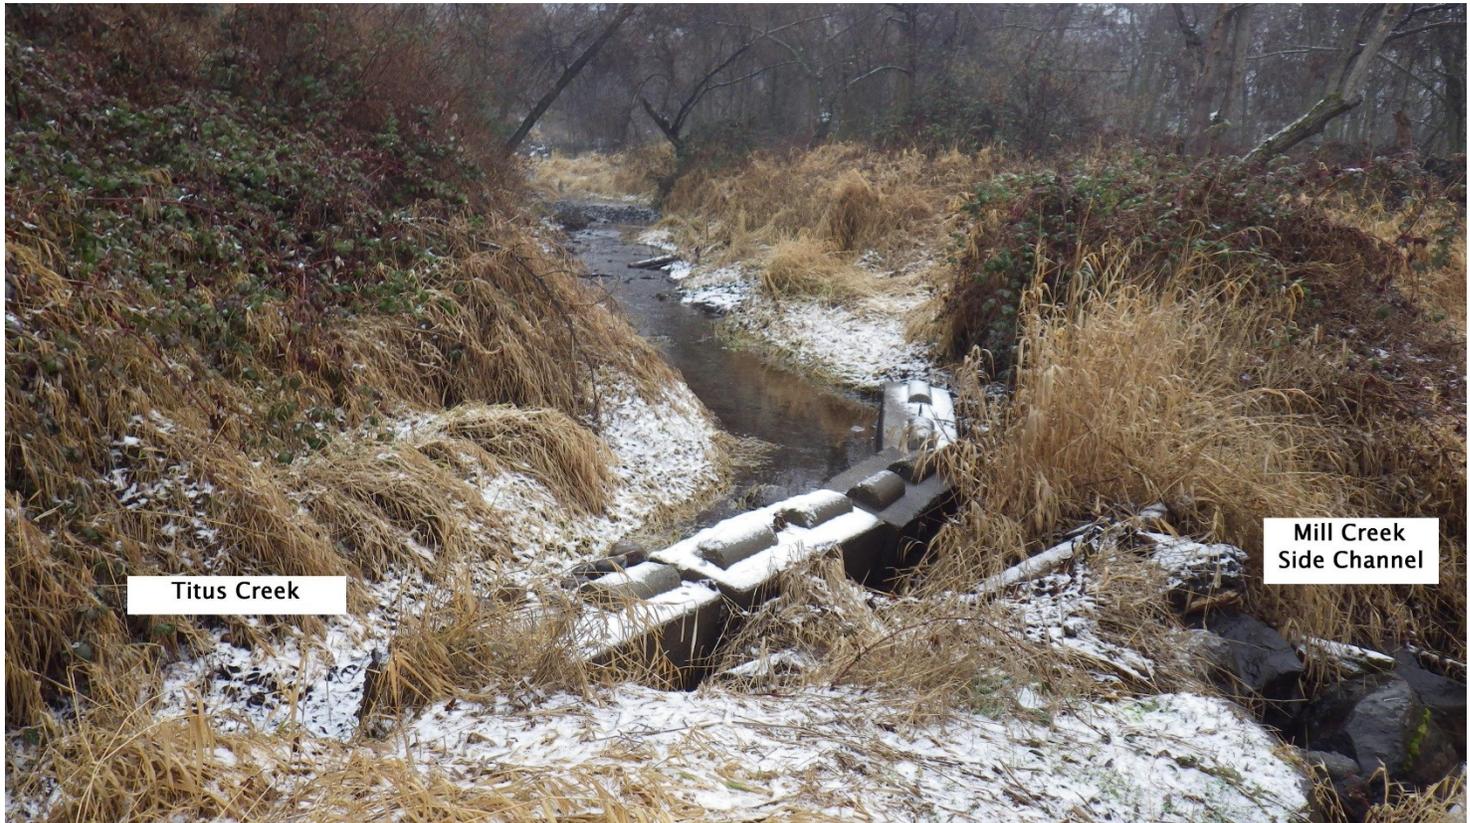
Before the project began, water was being diverted into Upper Titus Creek for irrigation by boulders and ecology blocks placed in the Mill Creek side channel. This structure blocked fish up-migration through the side channel and effectively guided out-migrating juvenile fish from the side channel into Upper Titus Creek. There juveniles were at risk from unscreened diversions and the seasonal dewatering of the creek, a potential cause of stranding and fish mortality.

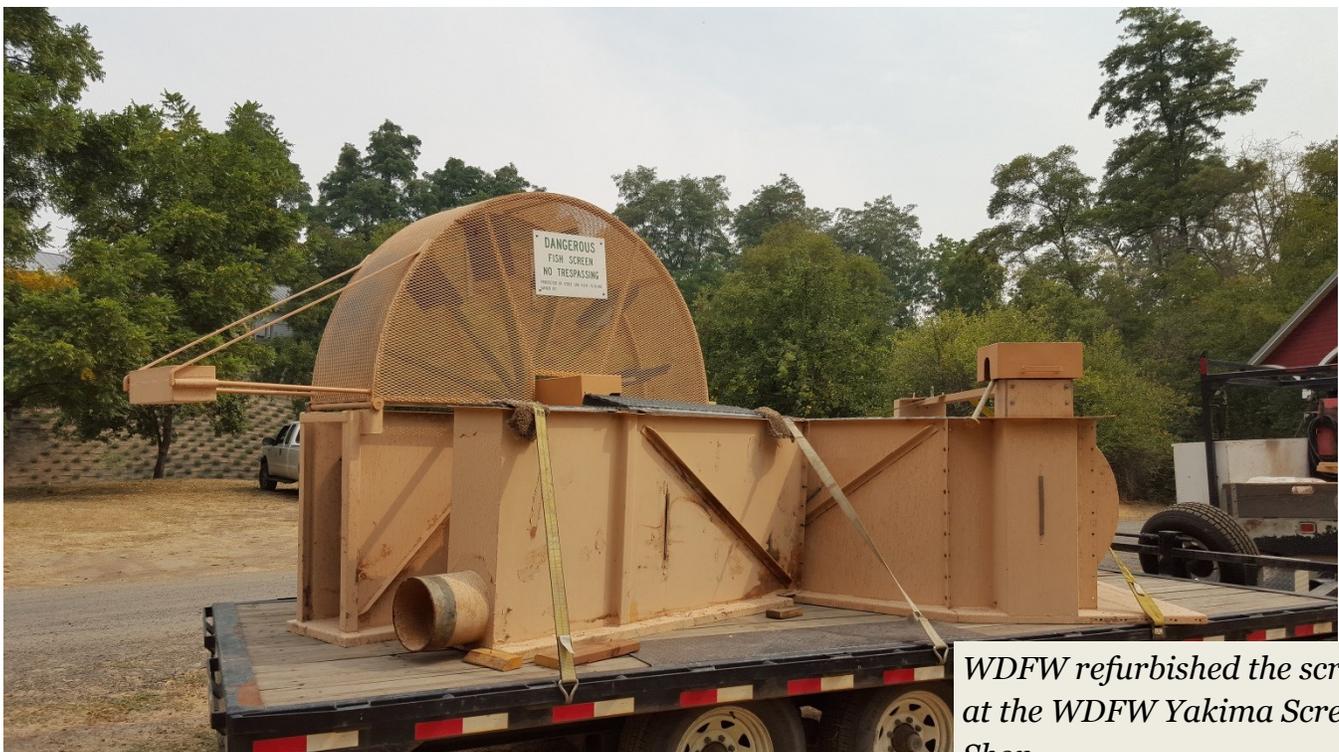
WDFW refurbished the screen at the WDFW Yakima Screen Shop.

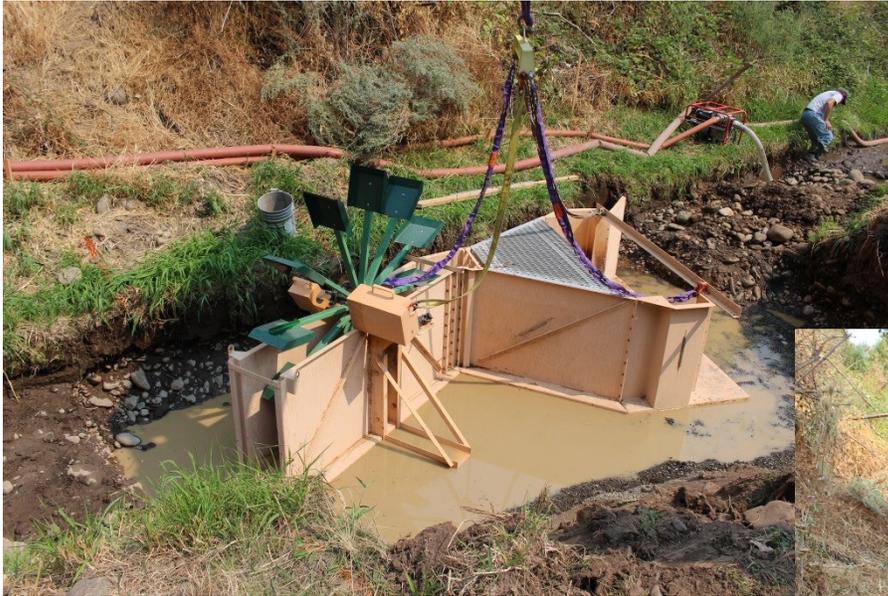
WDFW delivered and helped install the rotating drum screen.

The state-of-the-art screen was repurposed and donated by the WDFW Yakima Screen Shop, which also assisted in the delivery and installation of the screen. The screen system would return fish back to Mill Creek through the Mill Creek side channel.

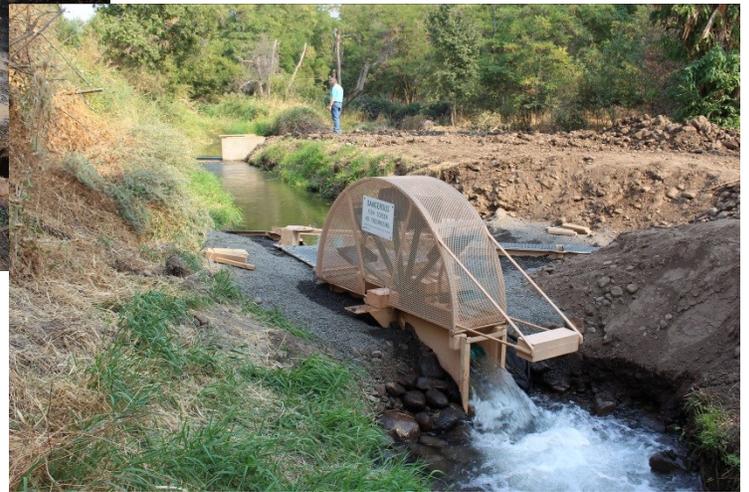
A manmade barrier (consisting of concrete blocks, slabs, and large riprap, used to divert water into the Upper Titus Creek) was removed and replaced by a step-pool type diversion structure. This provided fish passage between the upper and lower portions of the Mill Creek side channel. This area has dense and varied riparian canopy, cold, clear moderately moving water running over a cobbled streambed that are holding some deposited woody debris. Ten Large Woody Debris (LWD) structures were installed along the 1000' length of the Mill Creek channel. These structures mimic naturally occurring LWD structures and should begin natural wood recruitment in the channel. The project area was then planted by volunteers from Walla Walla University with native trees and shrubs.

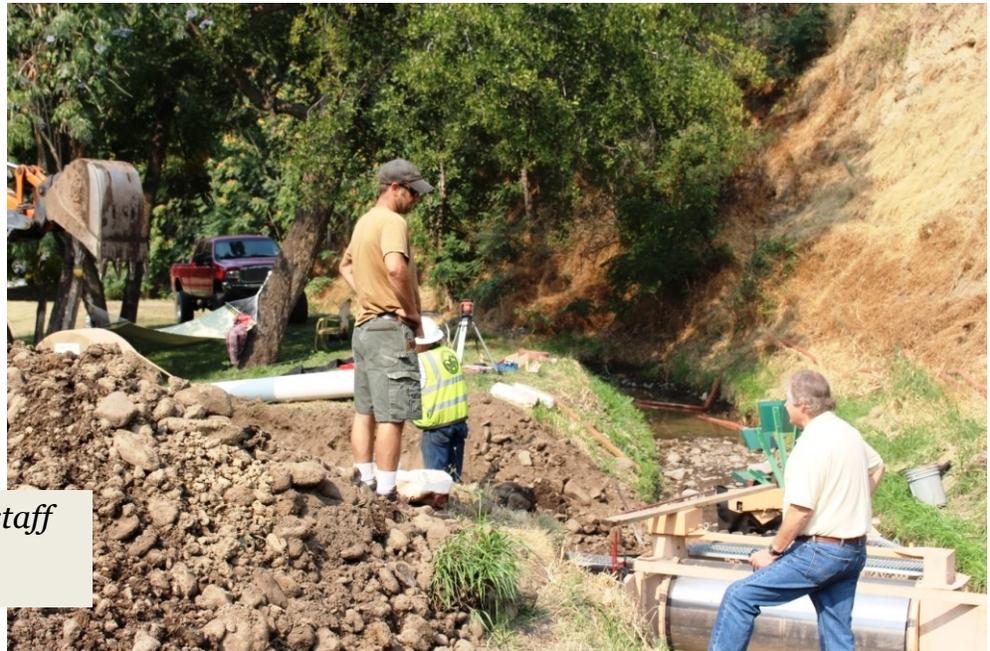
Landowner and district staff checking installation.

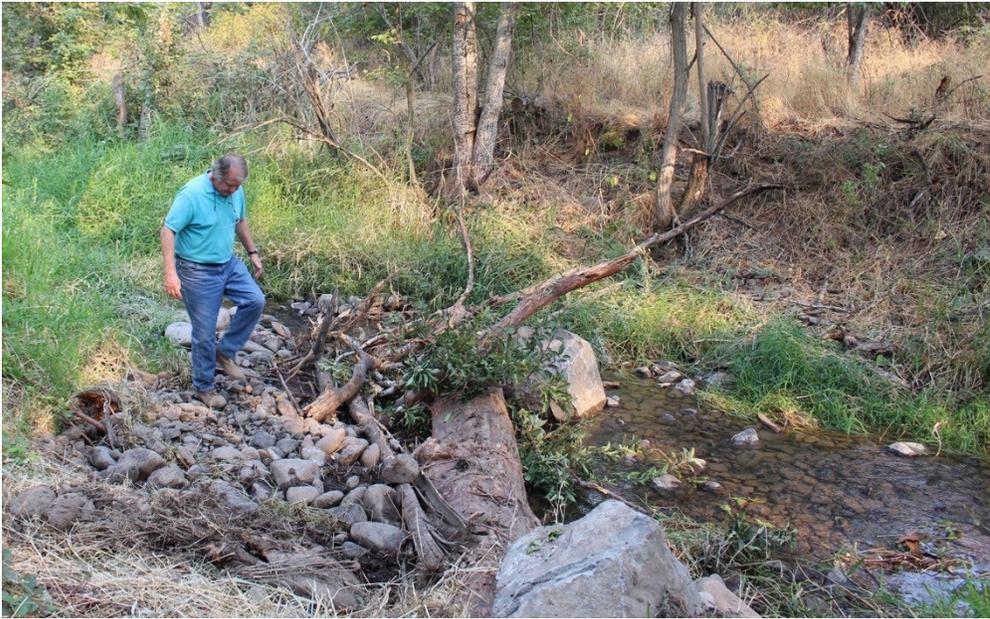
Large woody debris greatly improve habitat for salmonid species.

The final project screens the Upper Titus Creek completely, so salmonids are no longer at risk from irrigation diversions and stranding. The water flow routes fish into the Mill Creek side channel, which was improved with the addition of LWD structures. The project area was replanted with native trees and shrubs. The landowners have expressed their gratitude for a well-planned project that protects fish, improved habitat, and allowed them to continue irrigating without fear of harming endangered fish species.

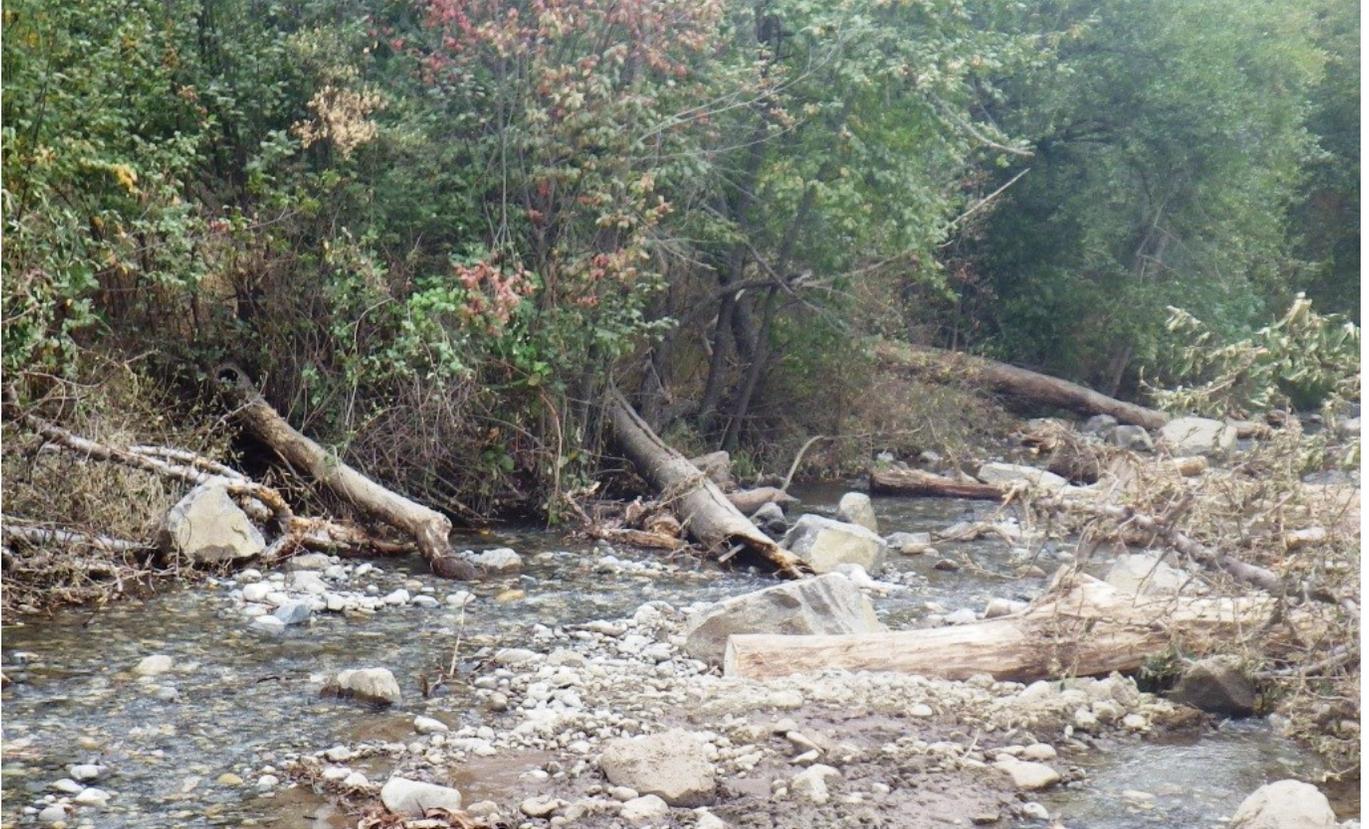
Large woody debris to improve fish habitat in the completed project.
